2023 Fall Conference, Ocean City, Maryland

**High Hazard Dam Rehabilitation Case Study:
Gerwig Lane Dam, Howard County, Maryland**

B. Gregory Adolph, P.E.

September 29, 2023

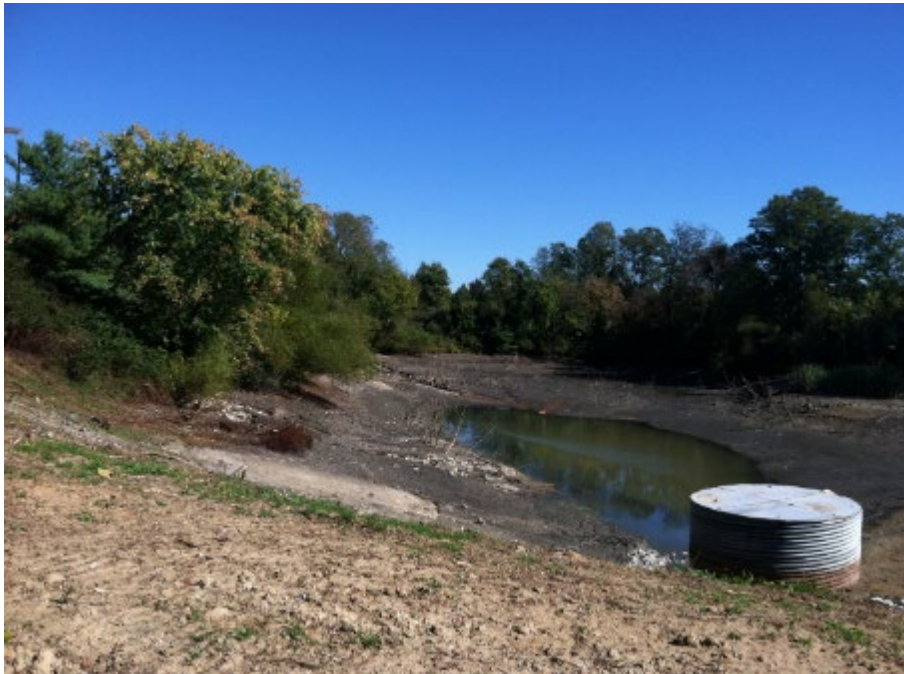
Site Prior to Retrofit

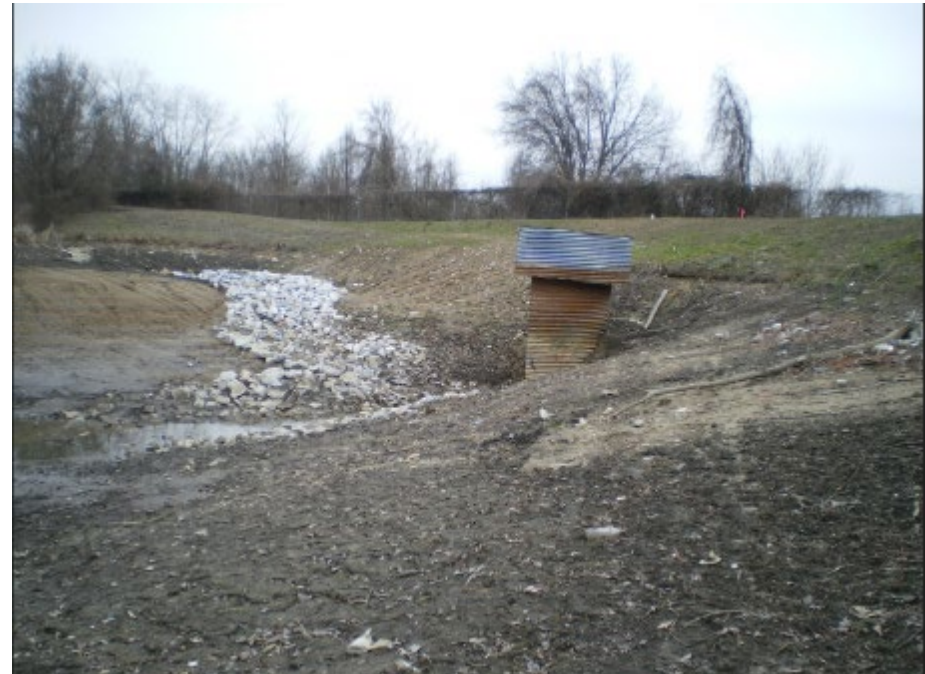
Riser Structure Corrosion

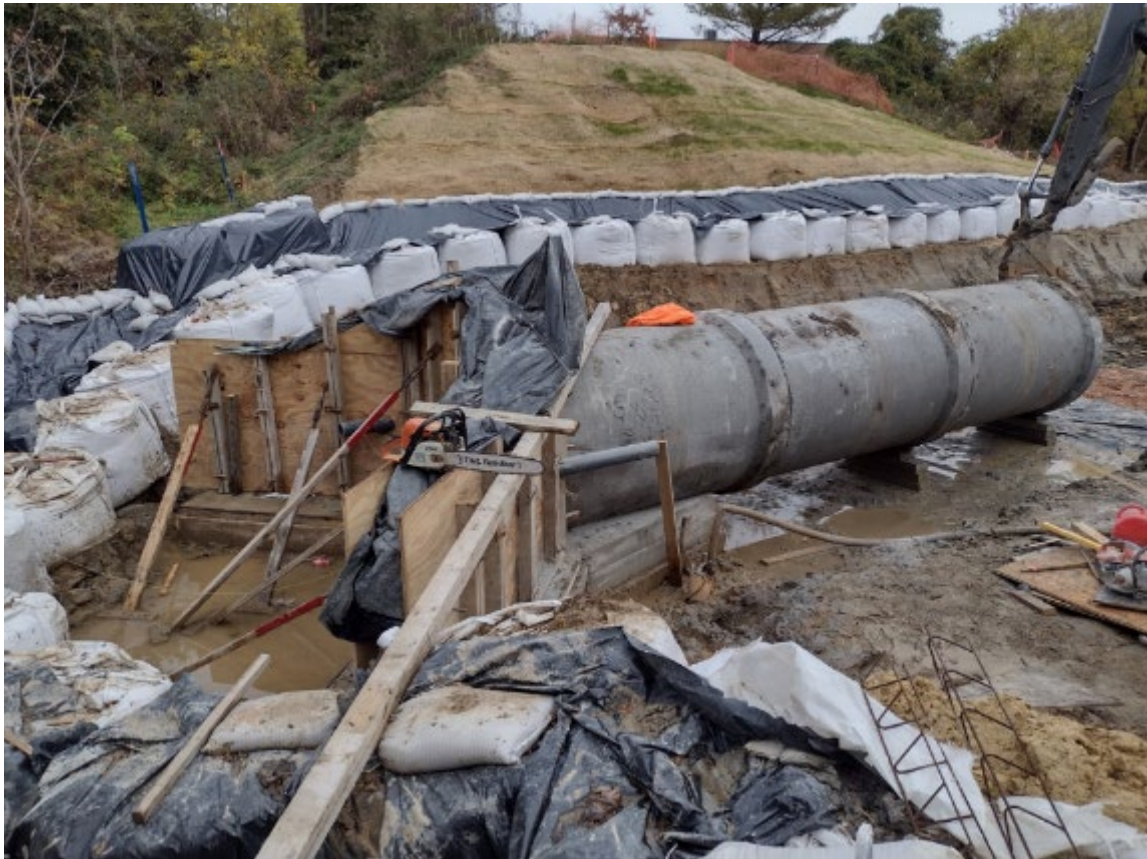
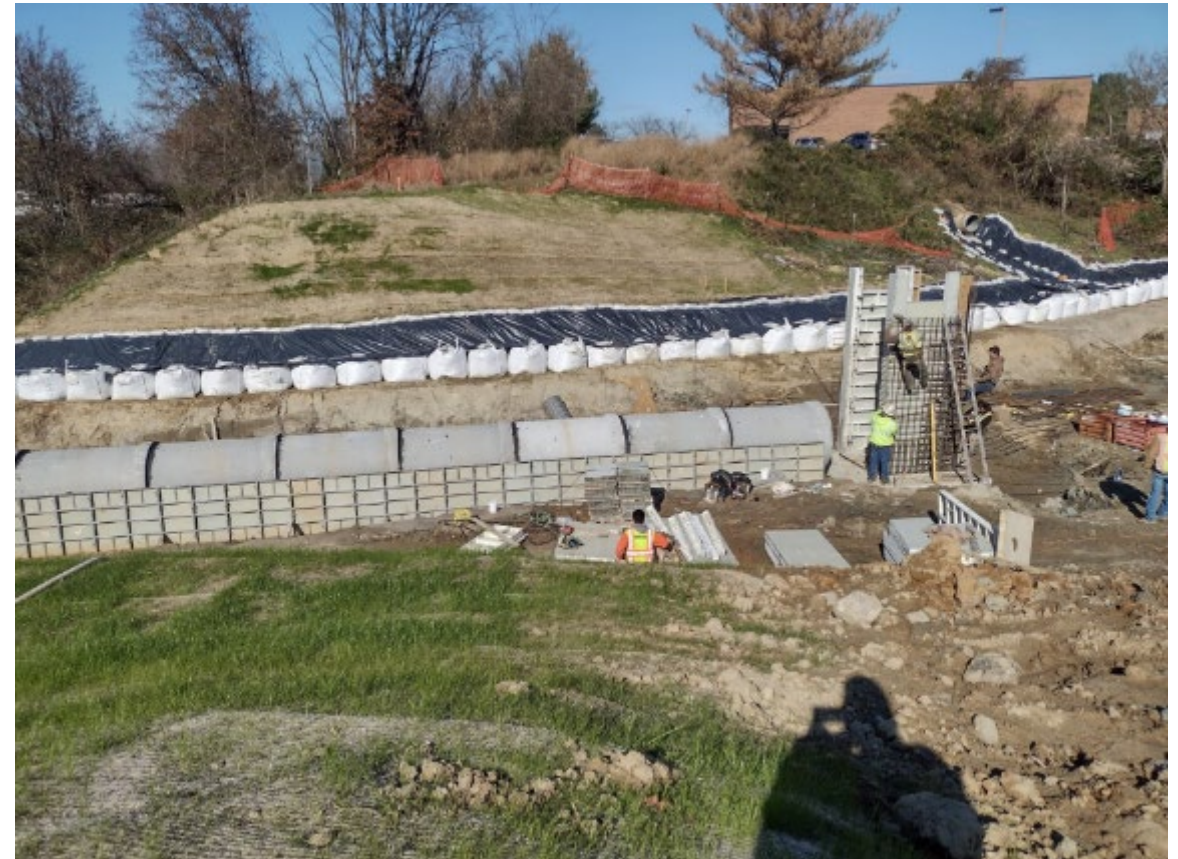
Reconstructed as Cast-In-Place Concrete Structures

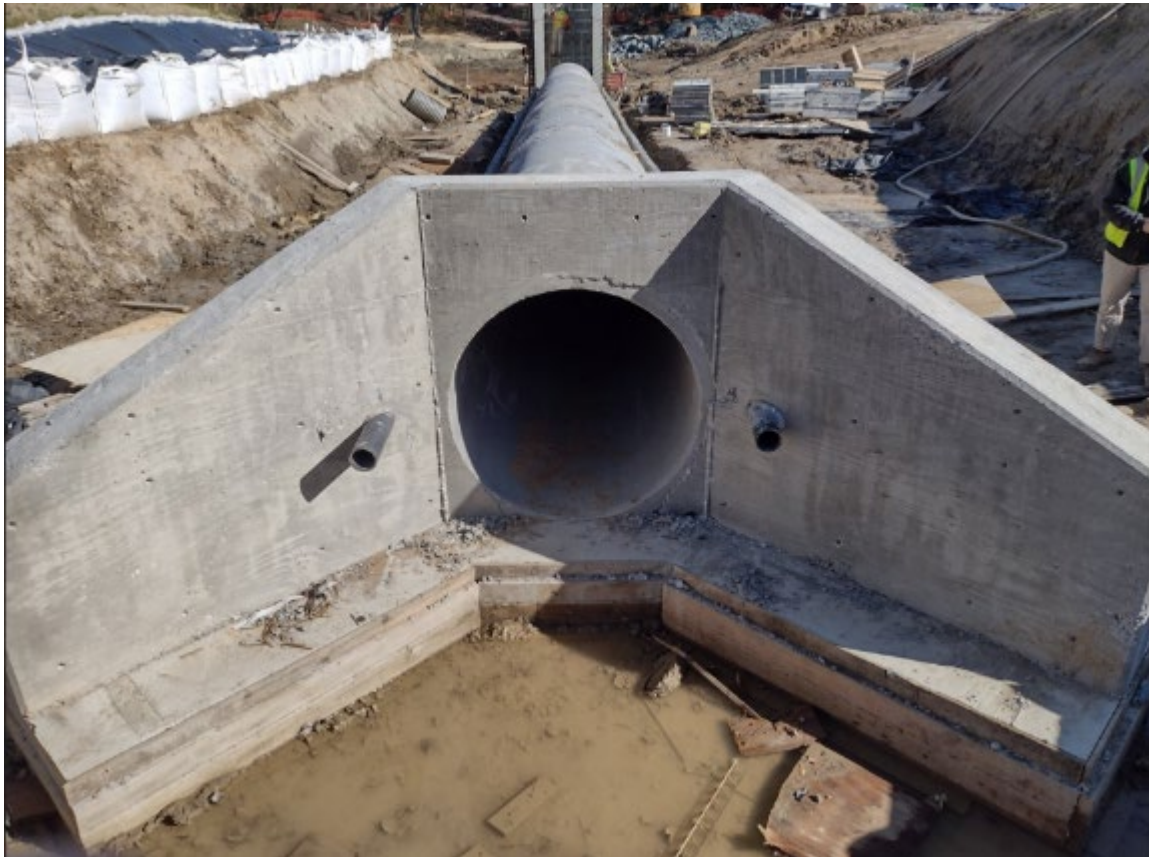
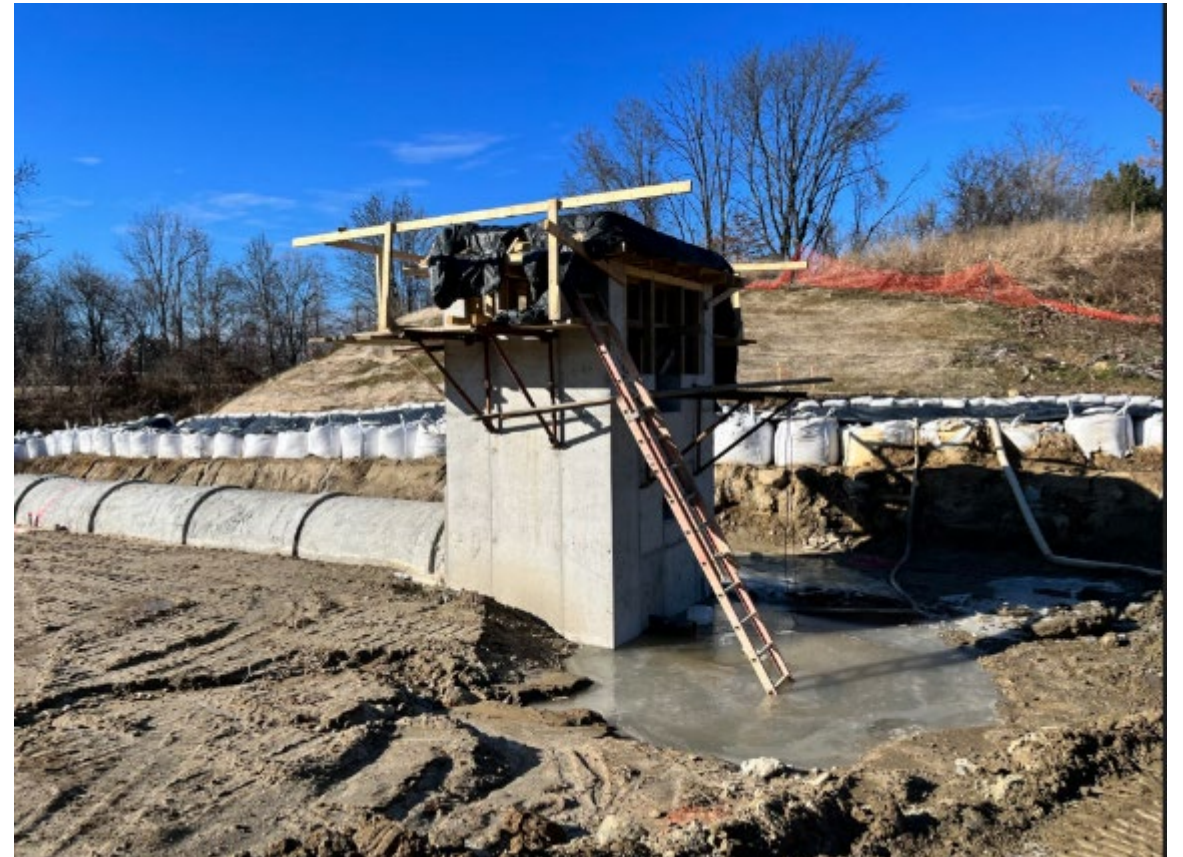
Practices to Prevent and Control Seepage

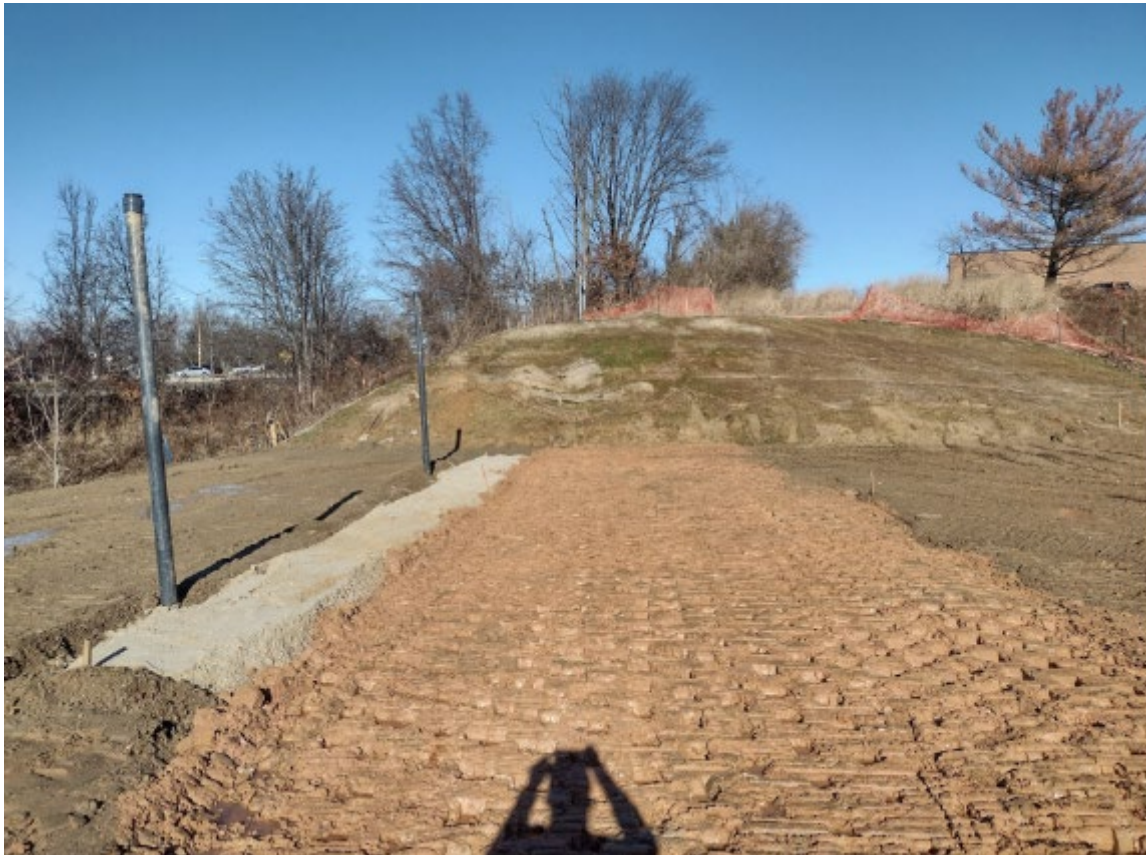
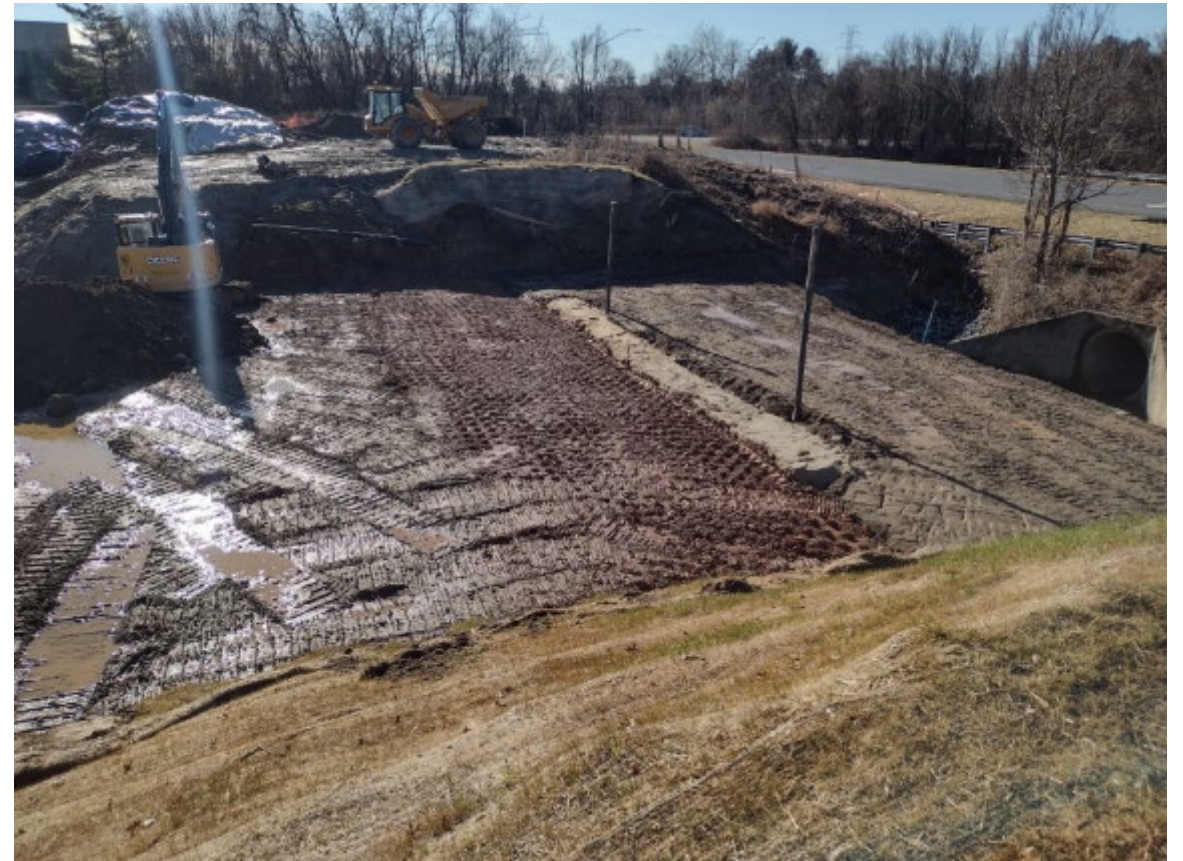
Fine Grading Before Subgrade Inspection

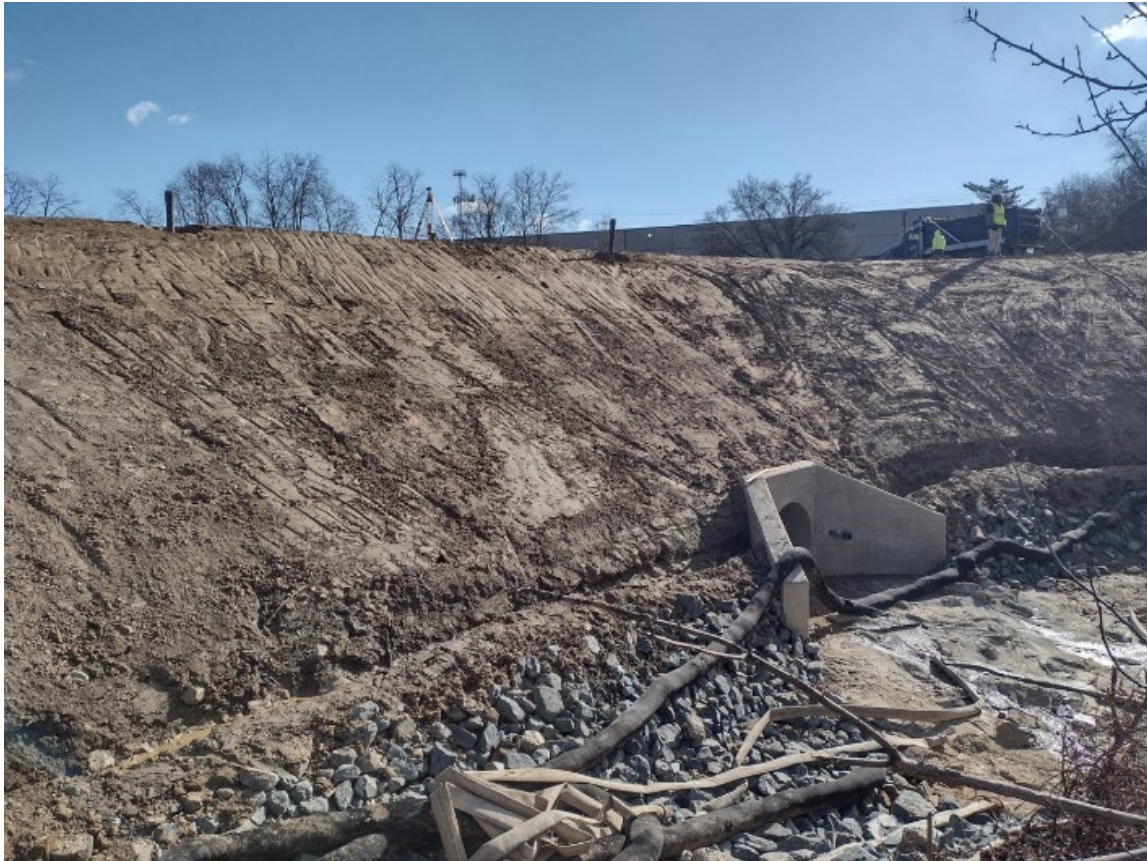
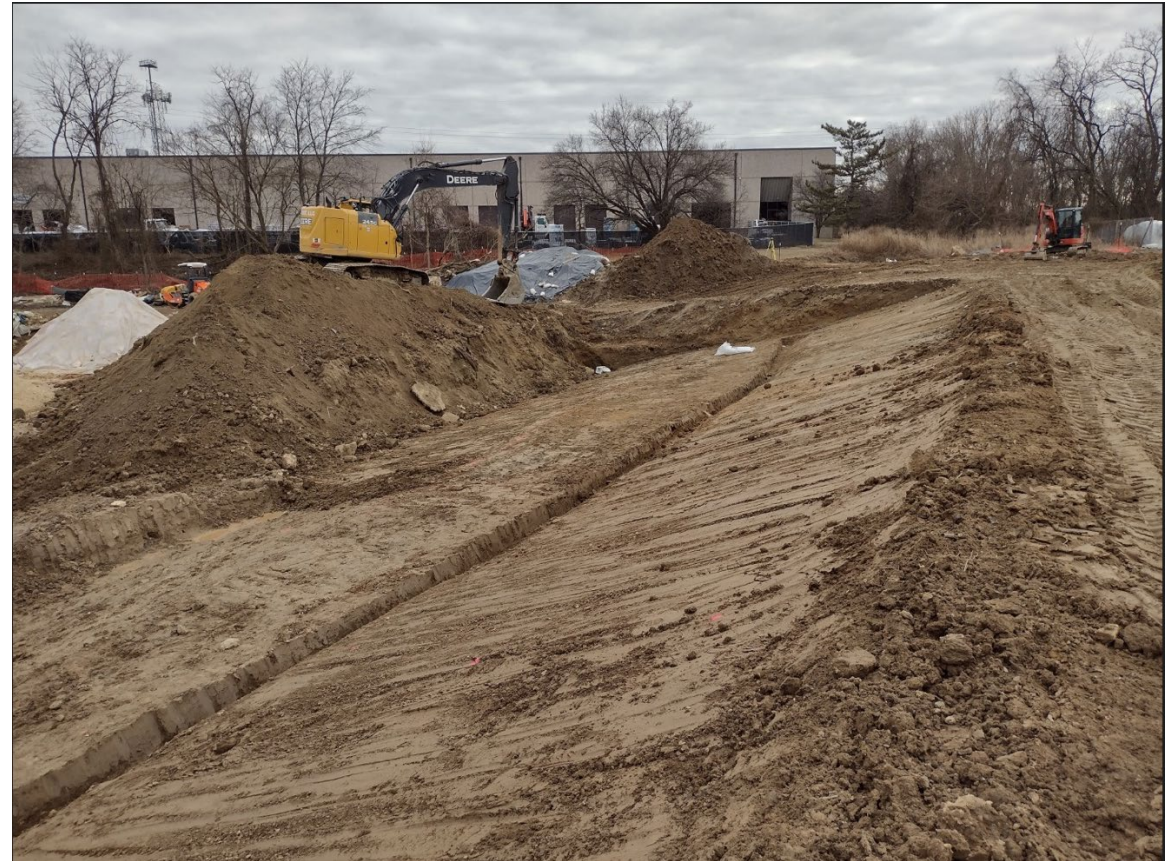
Anchor Trench Excavated During Fine Grading

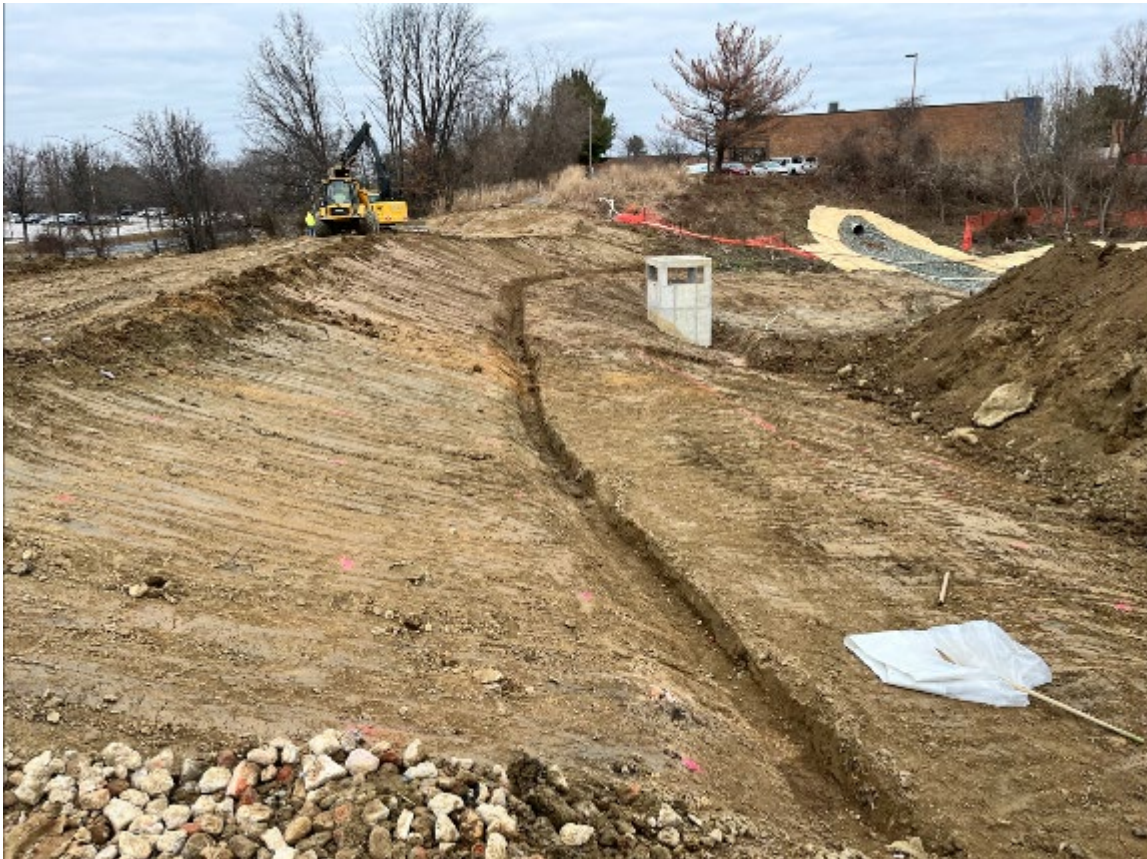
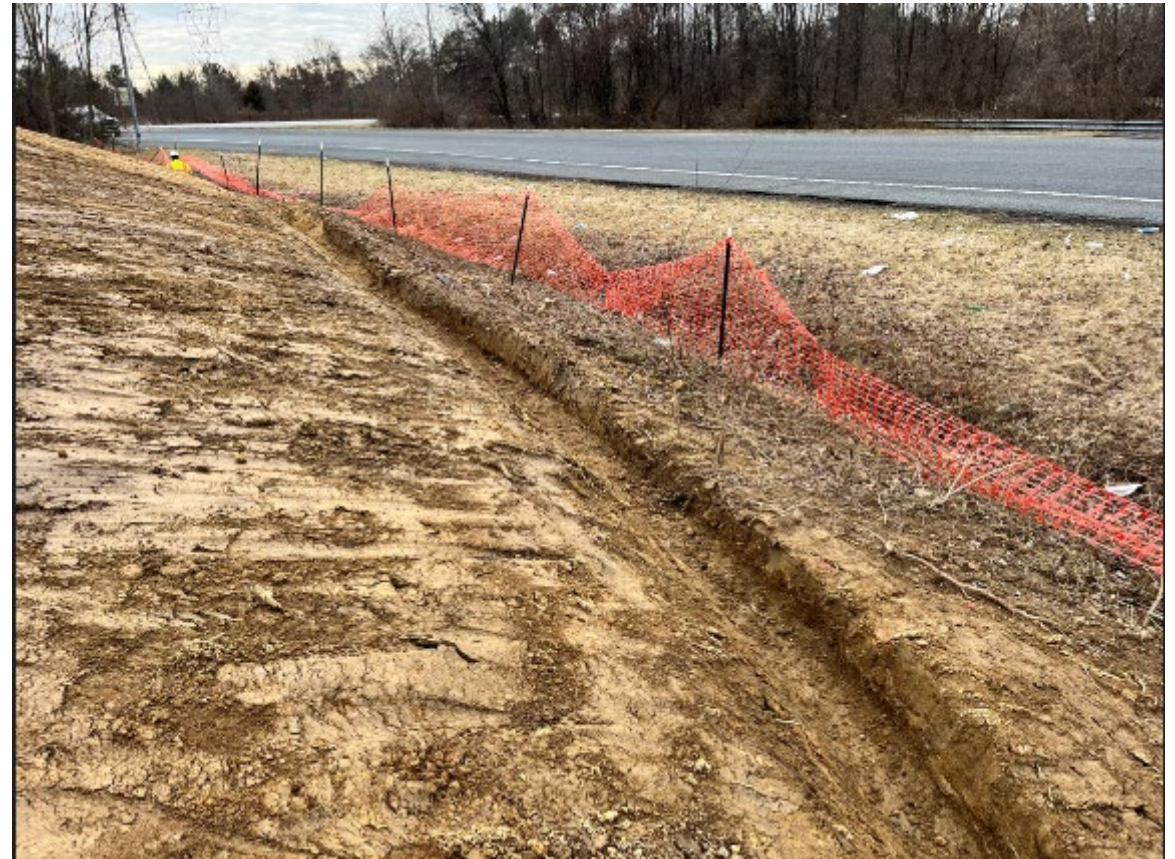
Subgrade Inspection by Geotechnical Engineer

- Consistent
- Firm and Unyielding
- Free of Material $> 3/4''$
- Visual Inspection and Soil Probe

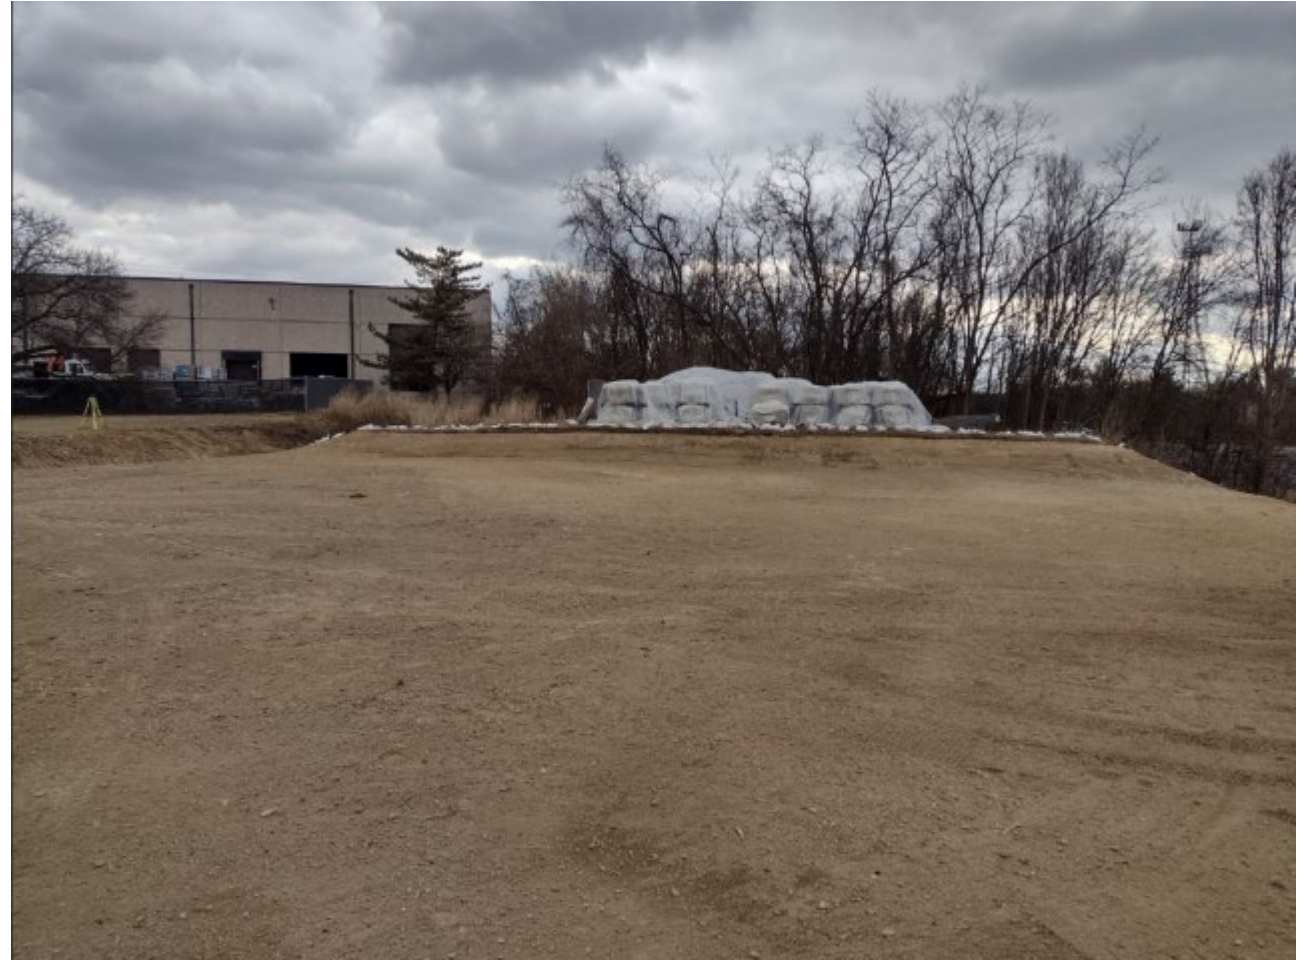
Specialists In Geosynthetic Membrane Installations

- Laid Out and Welded by Hand

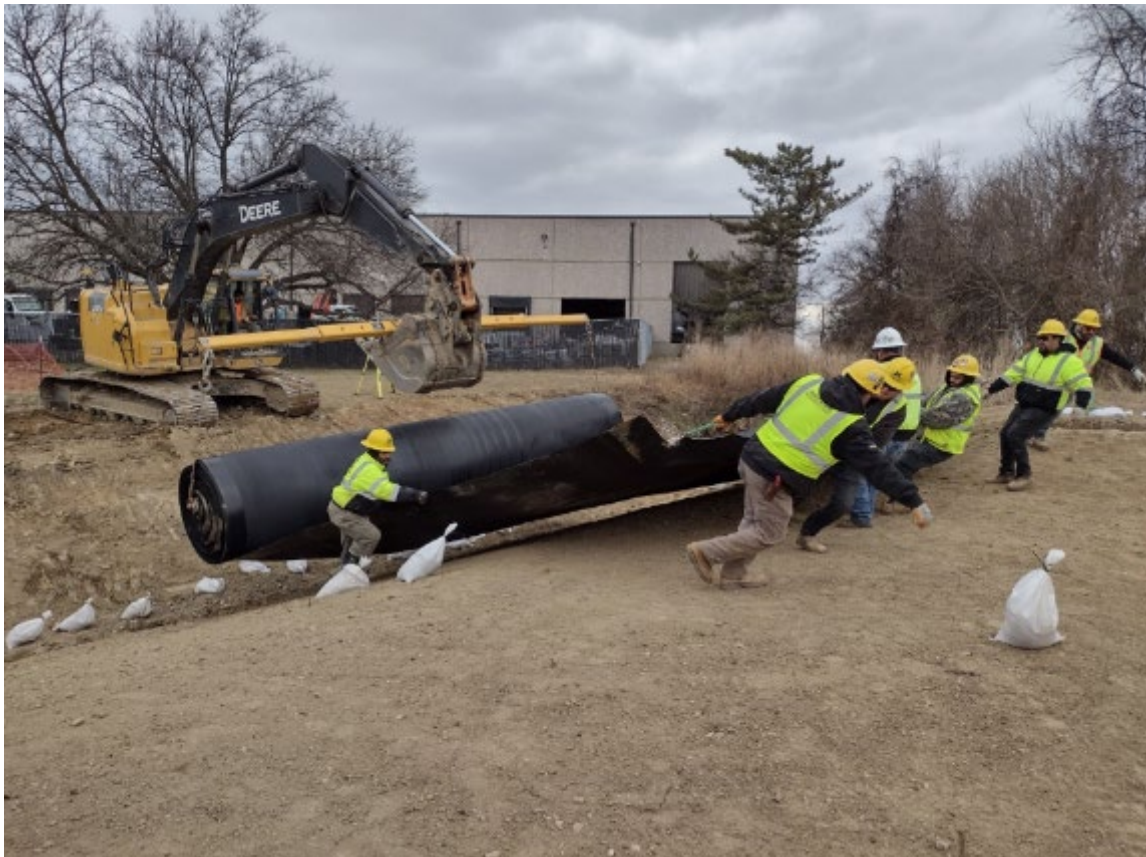
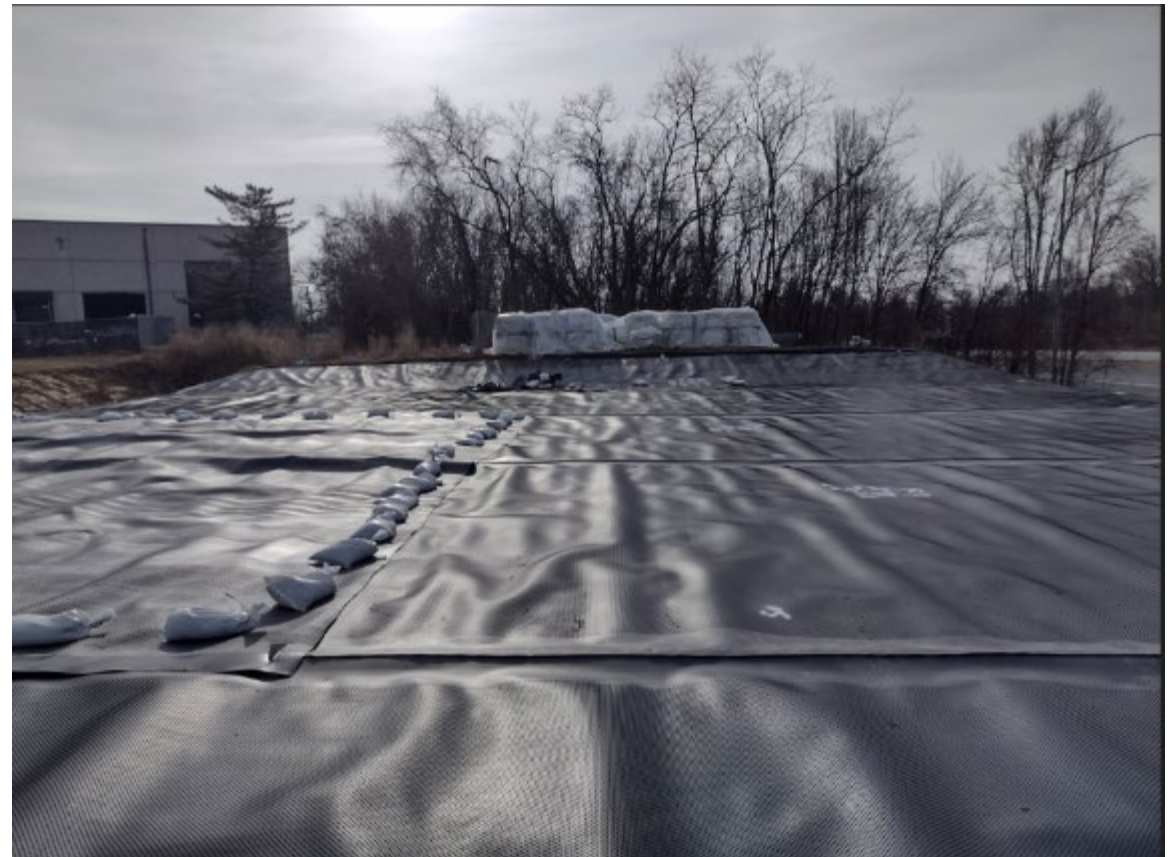
Quality Assurance

- Each Panel is Marked and Uniquely Identified and Tracked by Installers

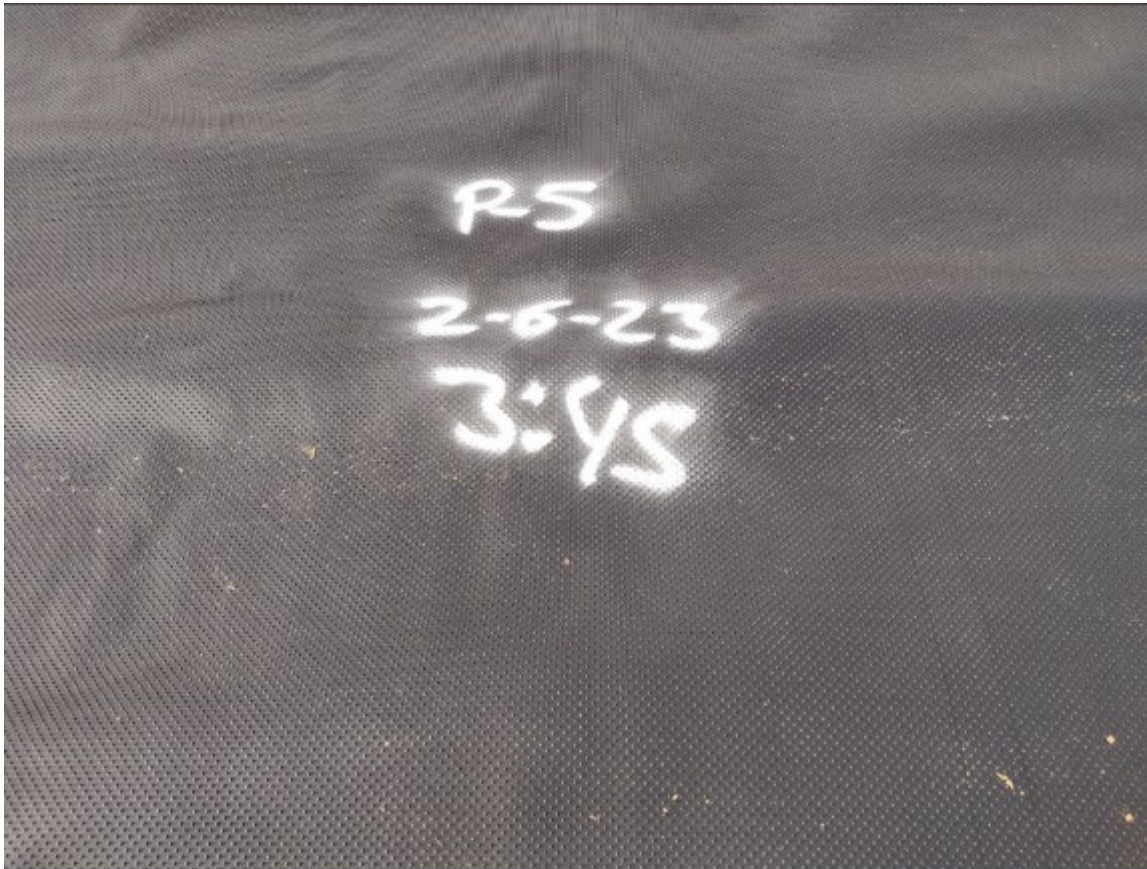
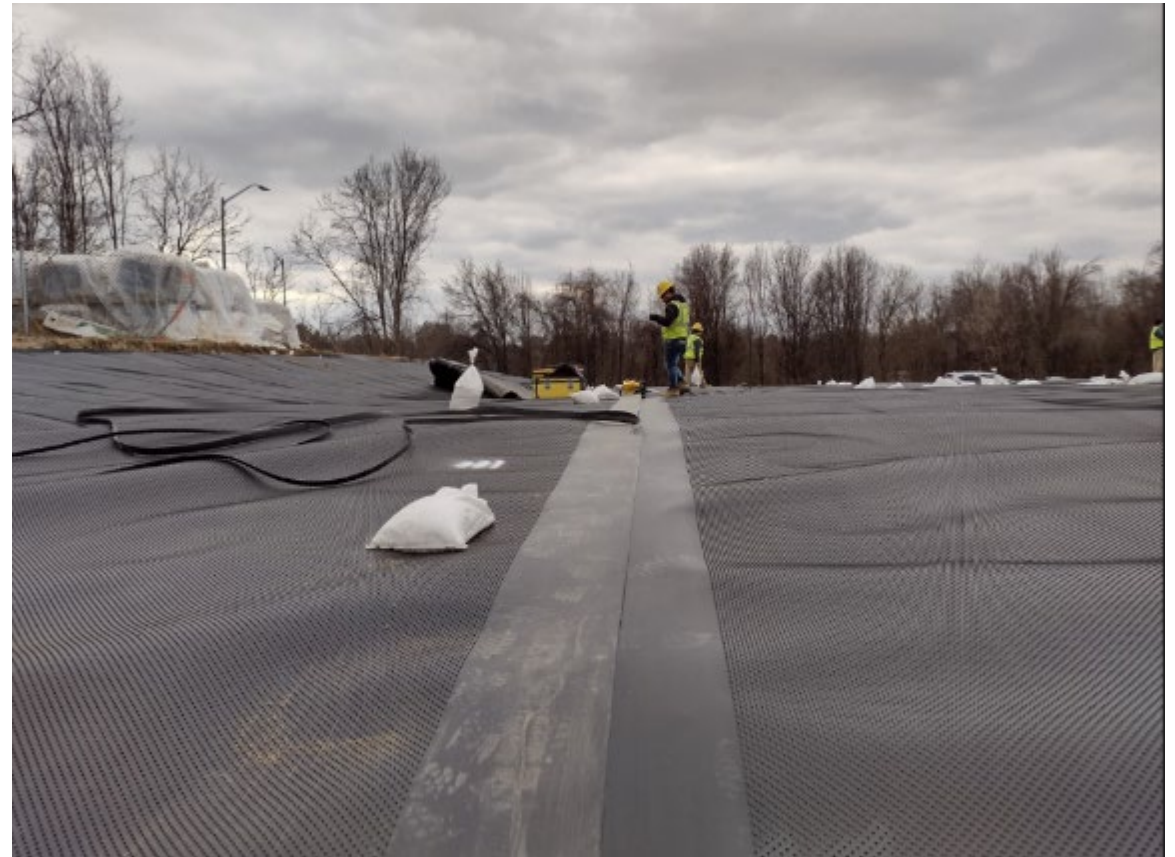
Pulled Out and Heat Bonded by Hand

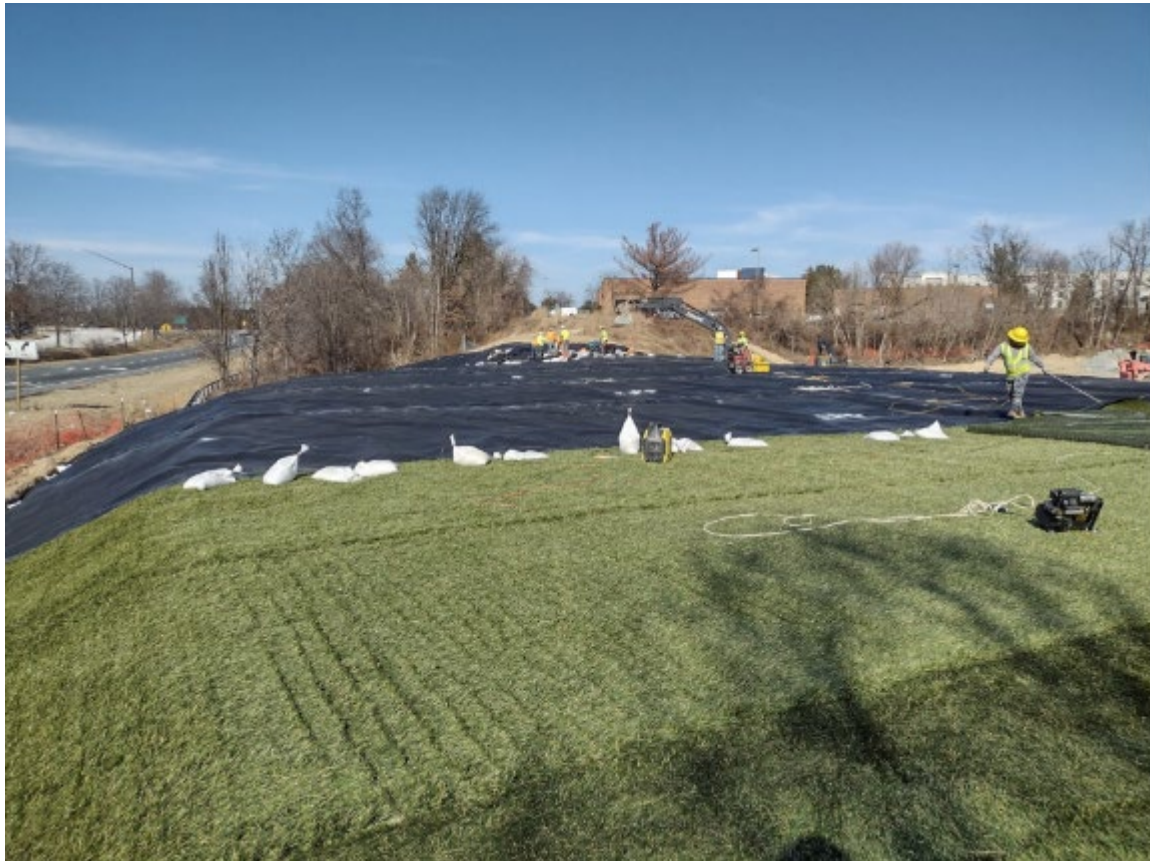
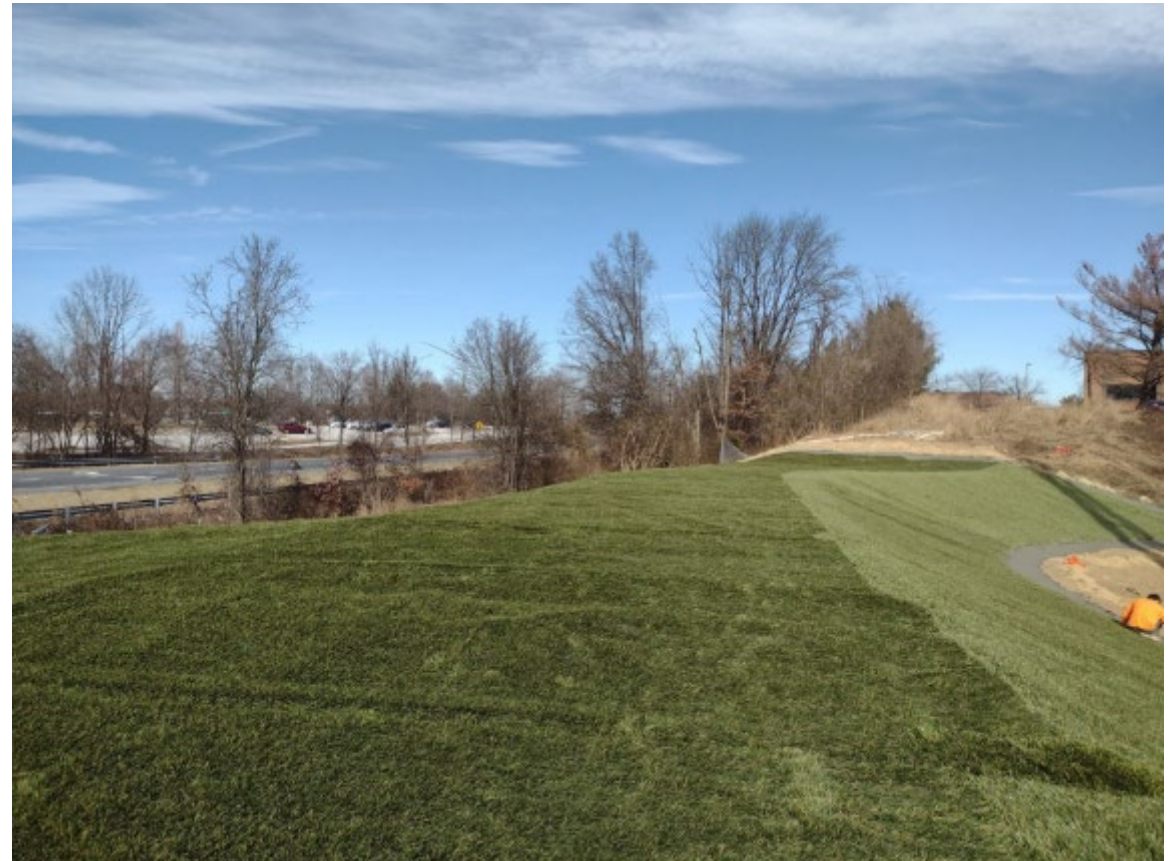
Final Installation Steps

- Weather Dependent
- 5000 PSI Traditional Concrete Anchor Trench
- 5000 PSI Granulated Cement Binder Infill
- Binder Raked in by Hand and Hydrated With Hose
