**2023 Fall Conference at Ashore Resort & Beach Club  
Ocean City, Maryland**

**Repair Process for the Thomas J. Hatem Memorial Bridge  
over the Susquehanna, Part II**

David S Lynch, PE (H&H) and Nafiz Alqasem, PE (MDTA)

September 29, 2023

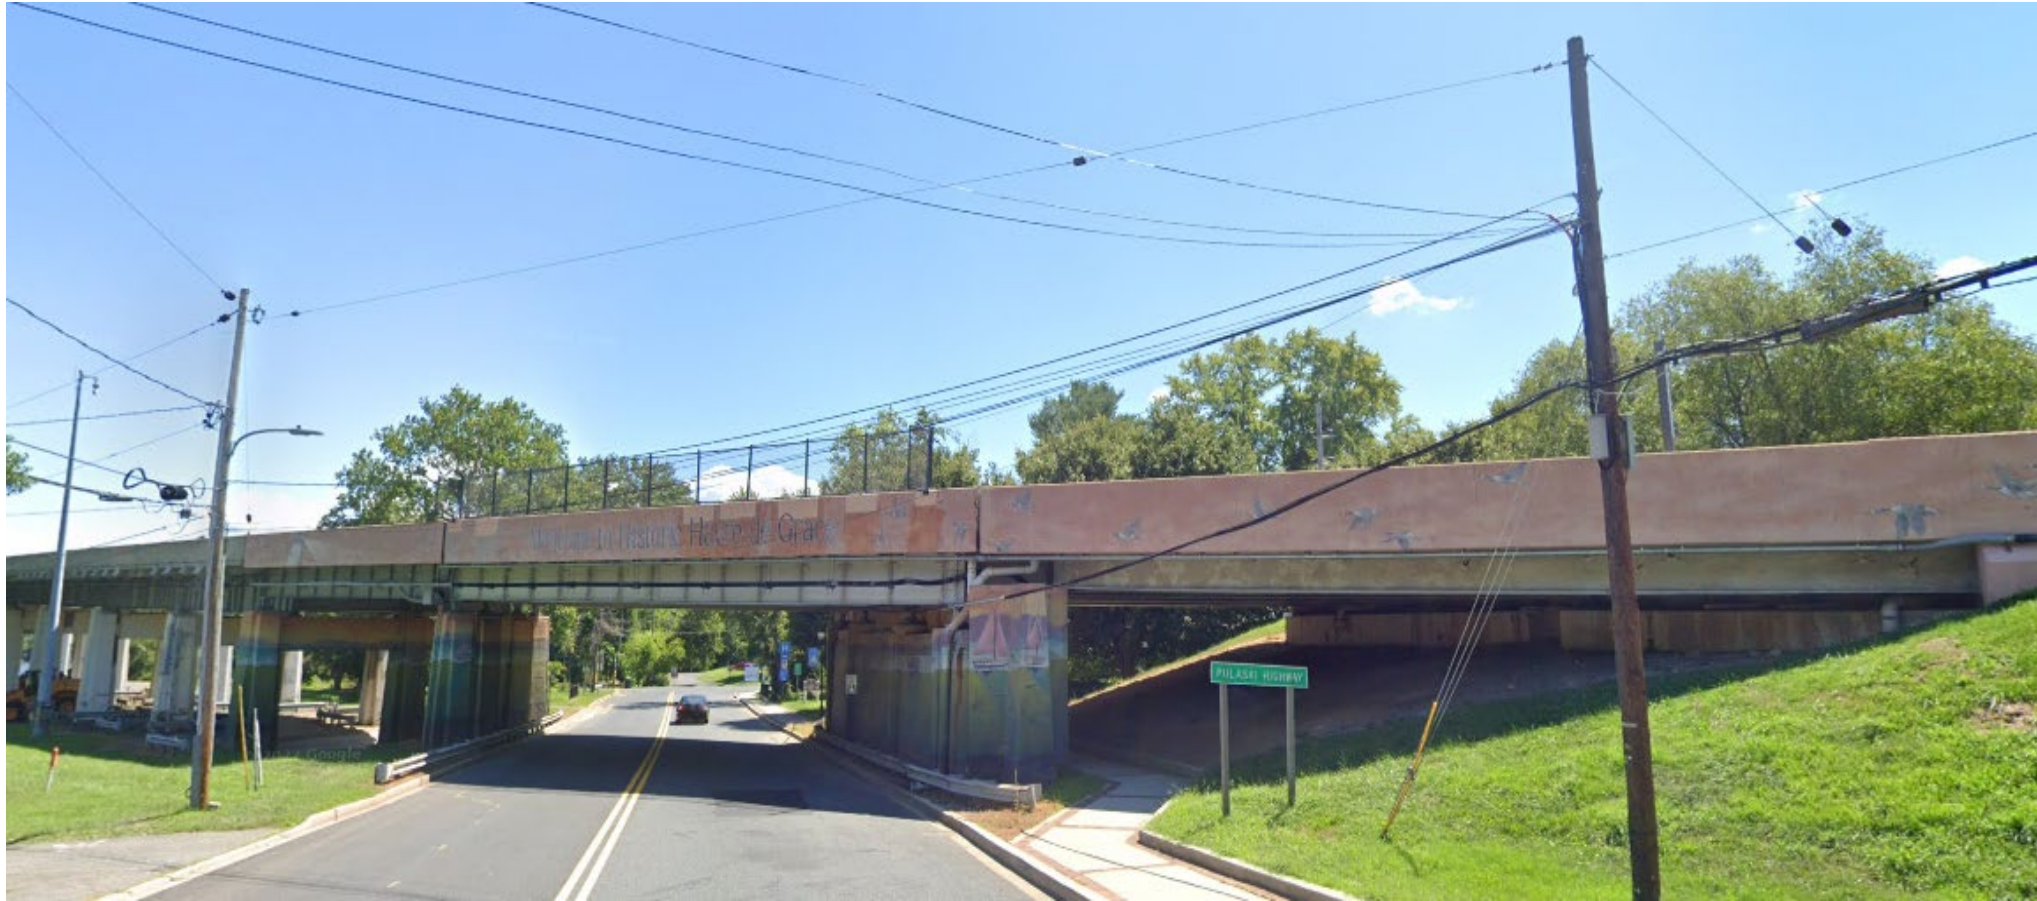
S0A – S01  
Shown

Beam Spans (2 Subunits): S0A – S01 and S52 - S54

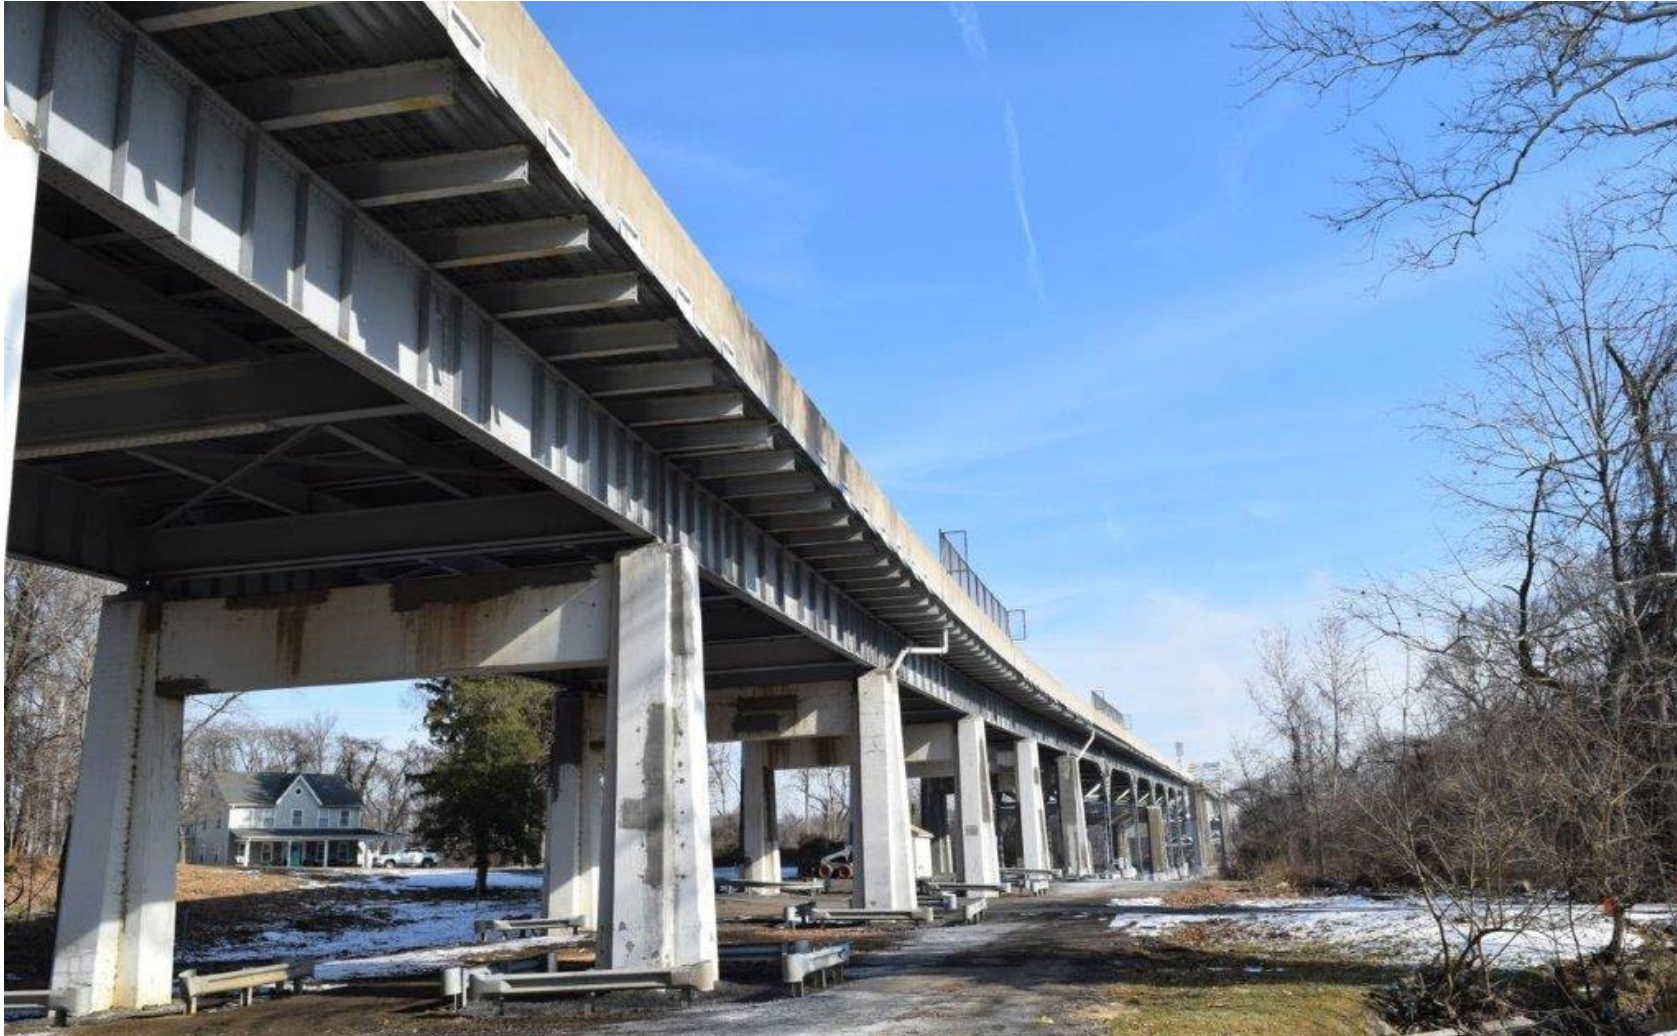
S02 – S09  
Shown

## Girder Spans (2 Subunits): S02 – S09 & S46 – S51

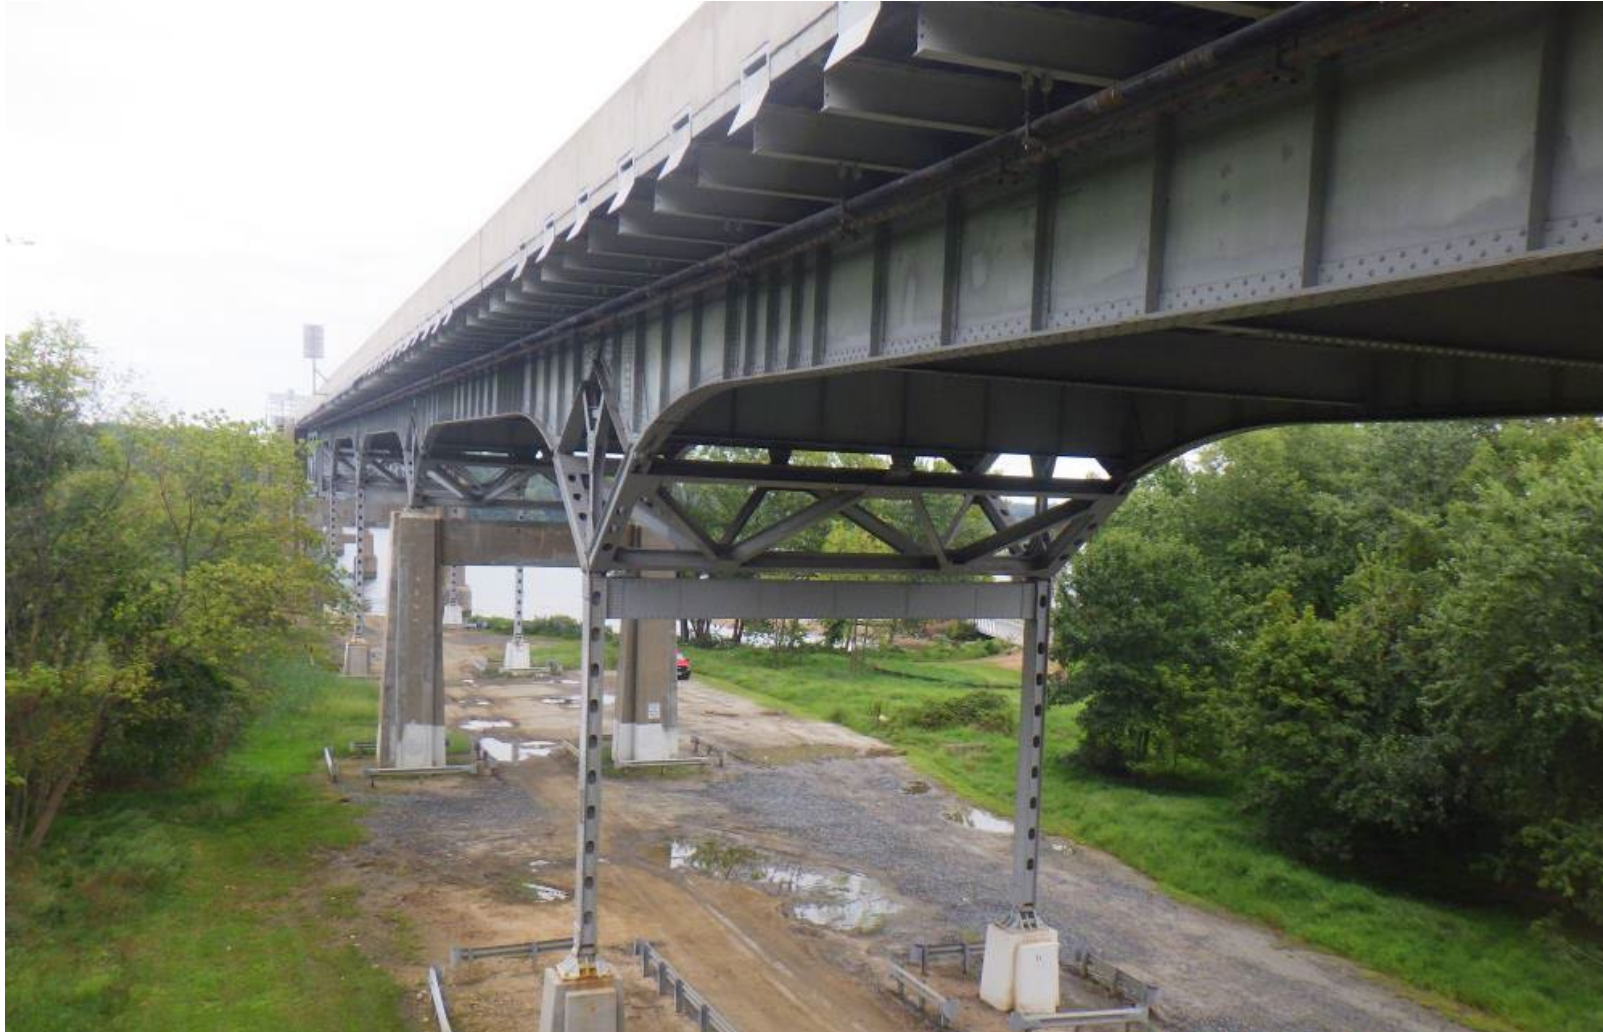
S10 – S15  
Shown

Wichert Girders (3 Subunits): S10 – S15, S22 – S35, & S42 – S45

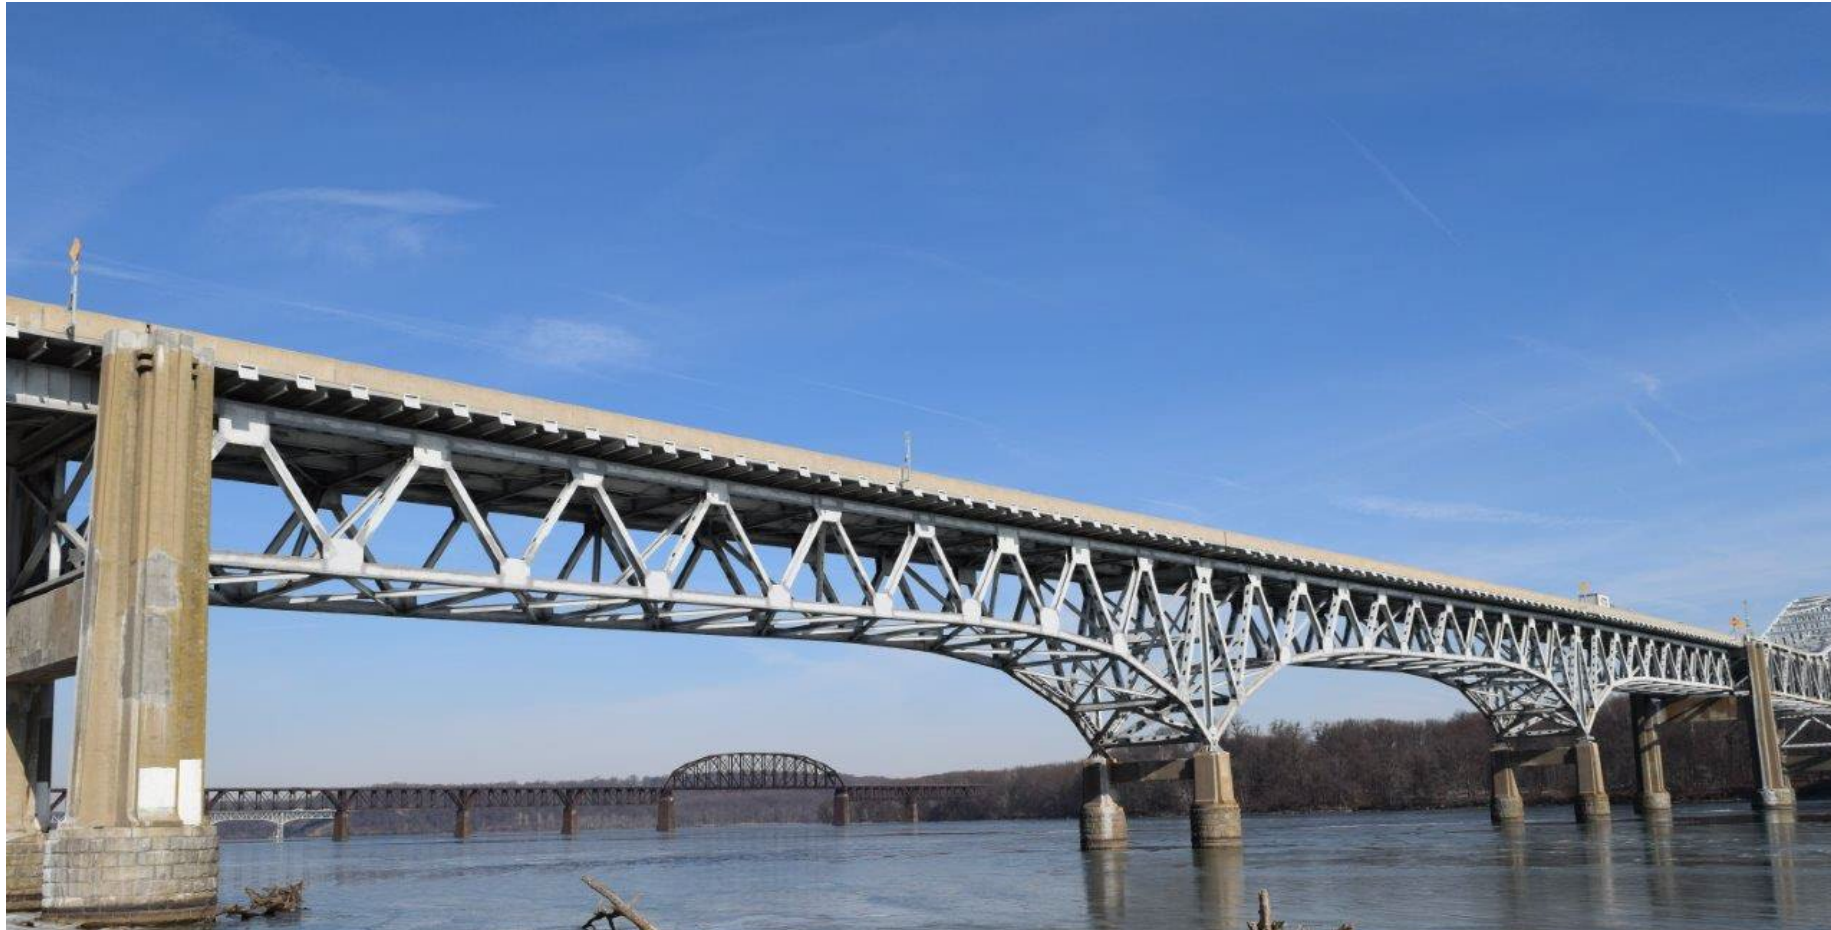
S16 – S18  
Shown

(Wichert) Deck Trusses (2 Subunits): S16 – S18 and S36 – S38

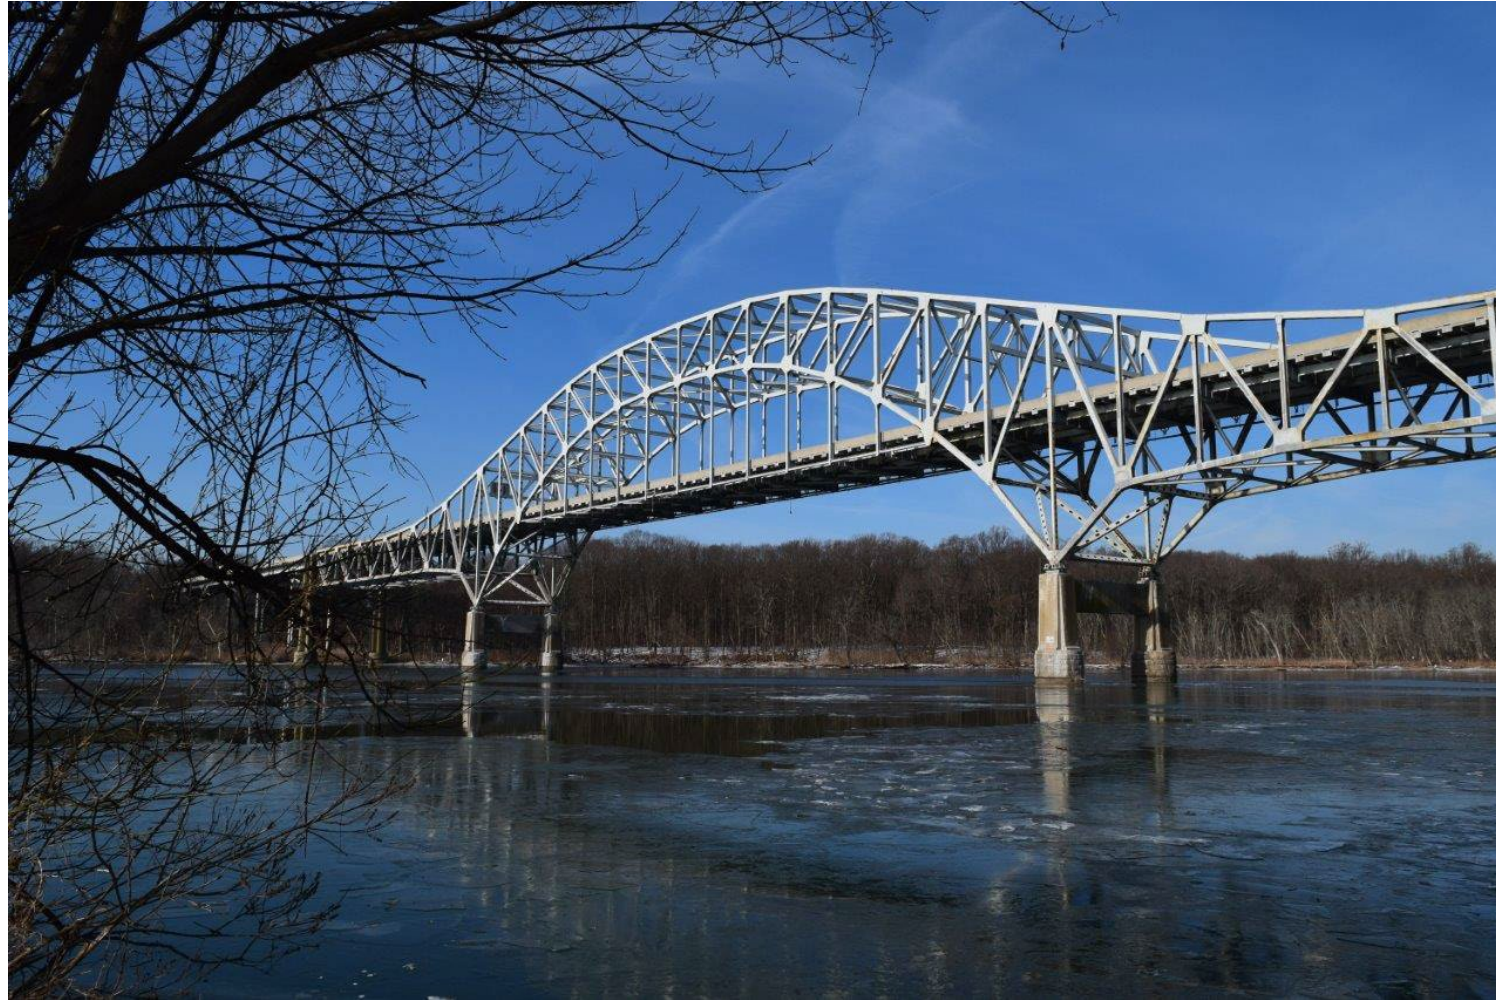
S36 – S38  
Shown

# Magnitude of Bridge (Wichert) Through Trusses (2 Subunits): S19 – S21 and S36 – S38

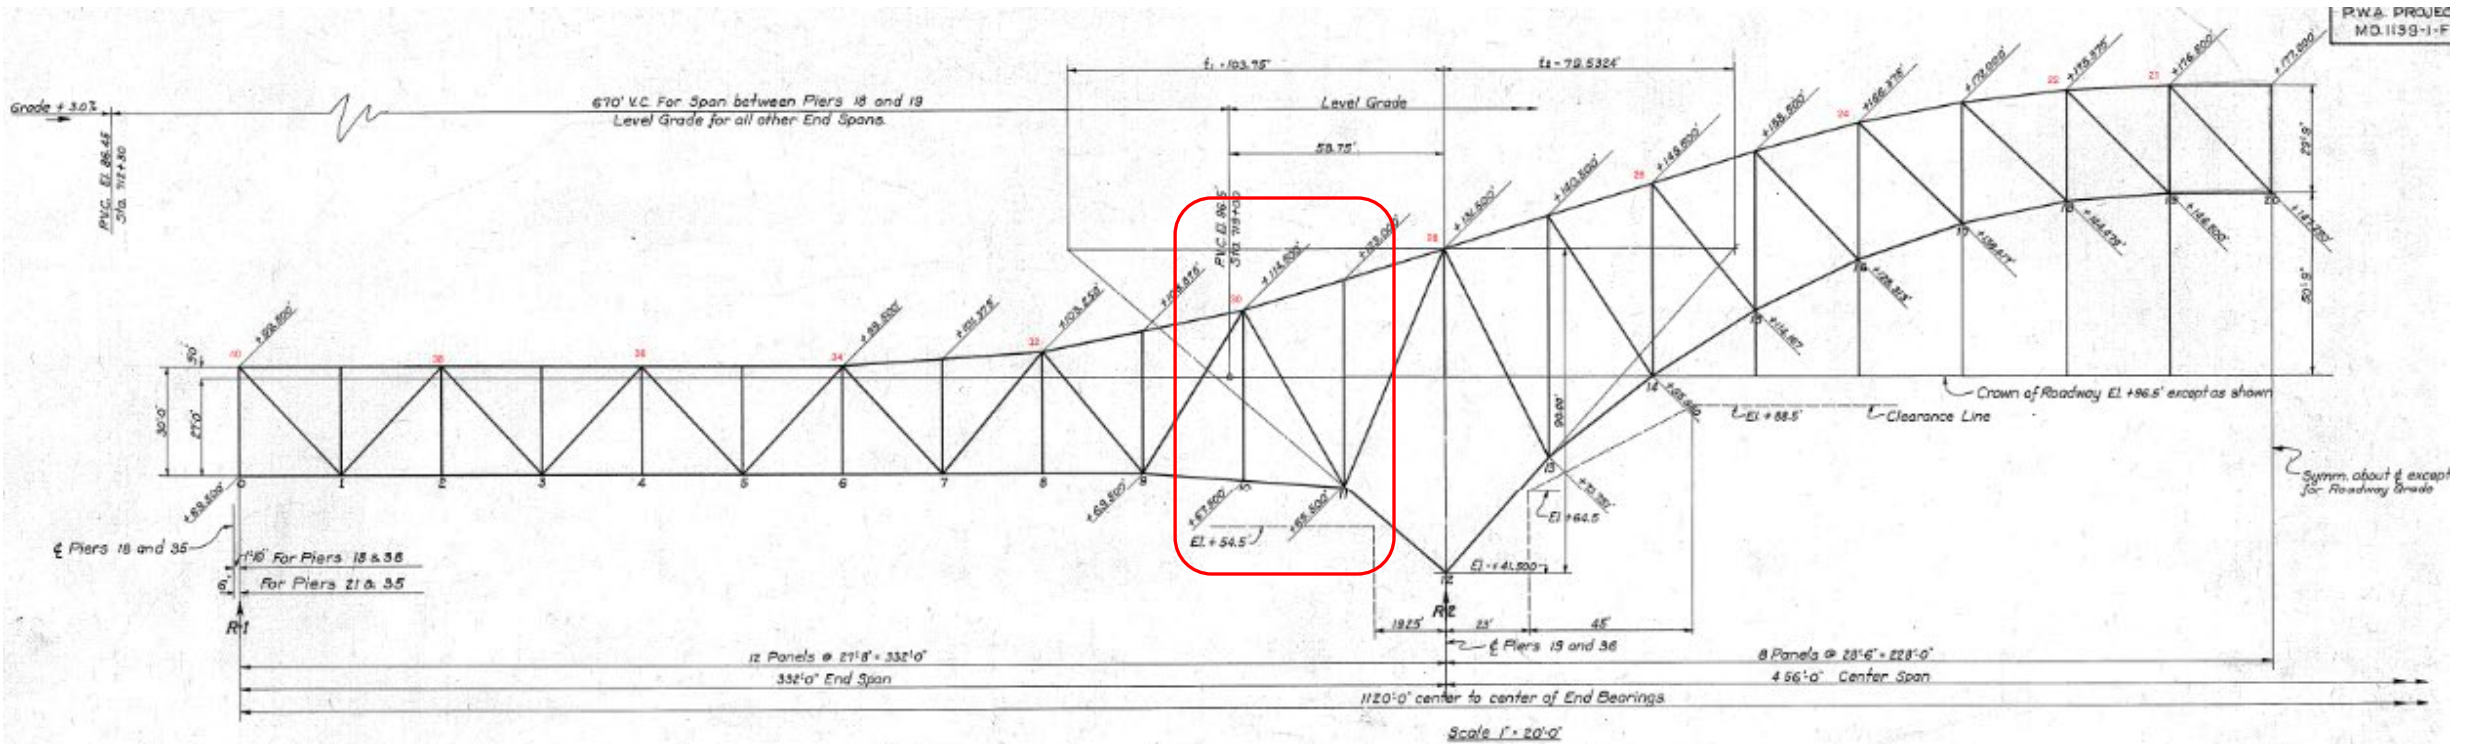
- Statically Determinate Designs
- EFFICIENT use of materials

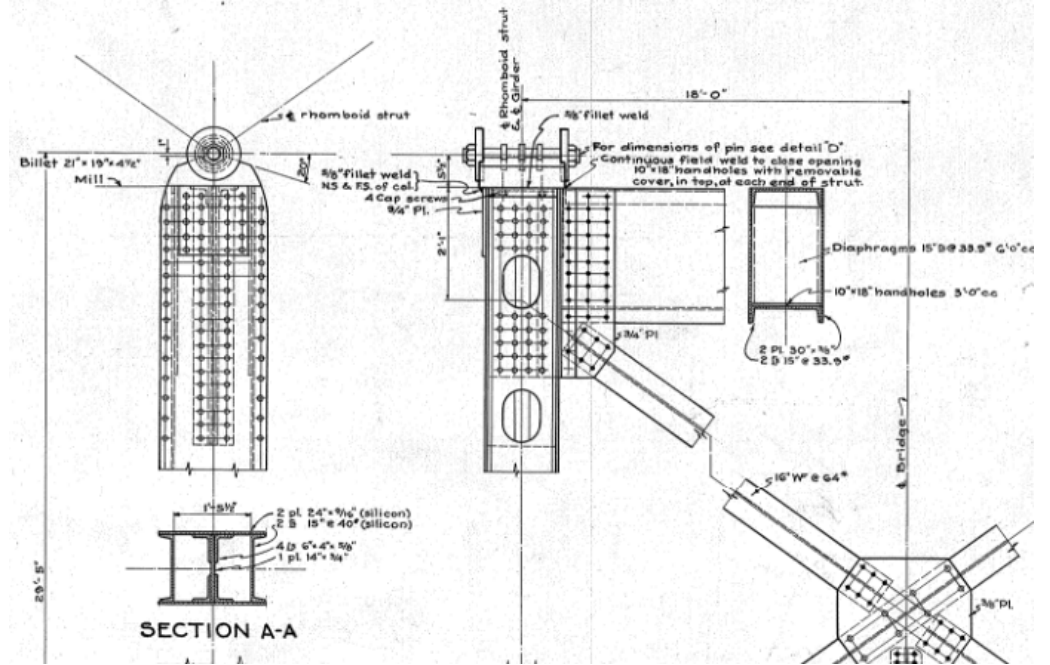
Plans show three configurations for tops of steel columns including Pier 44

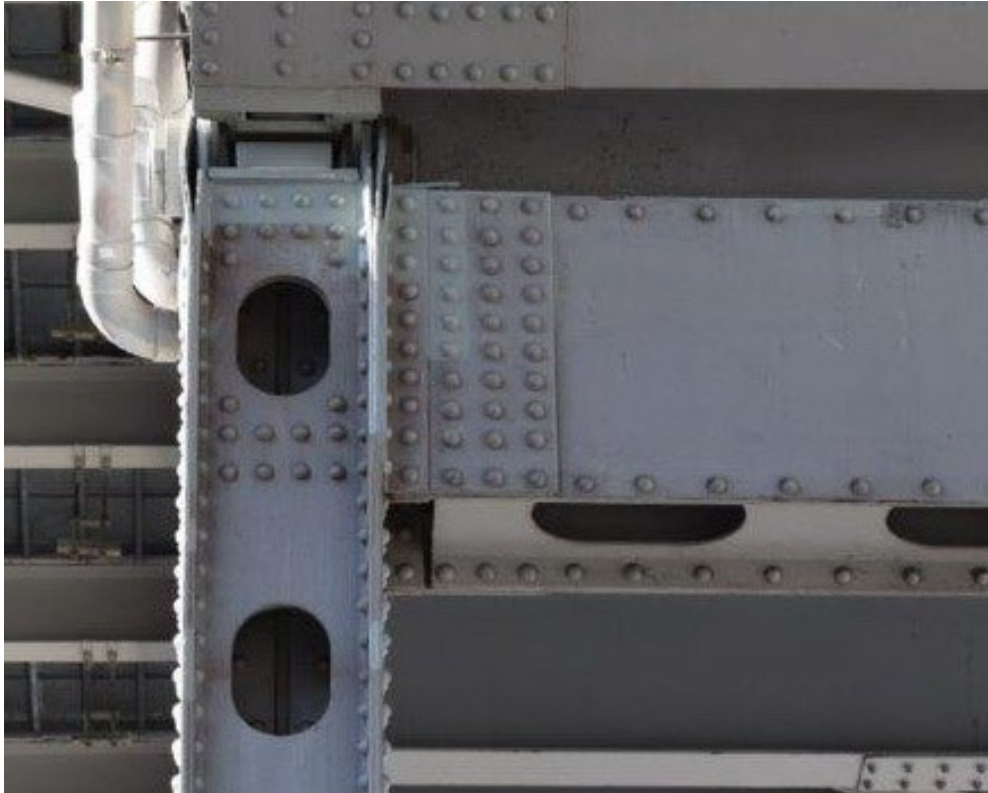
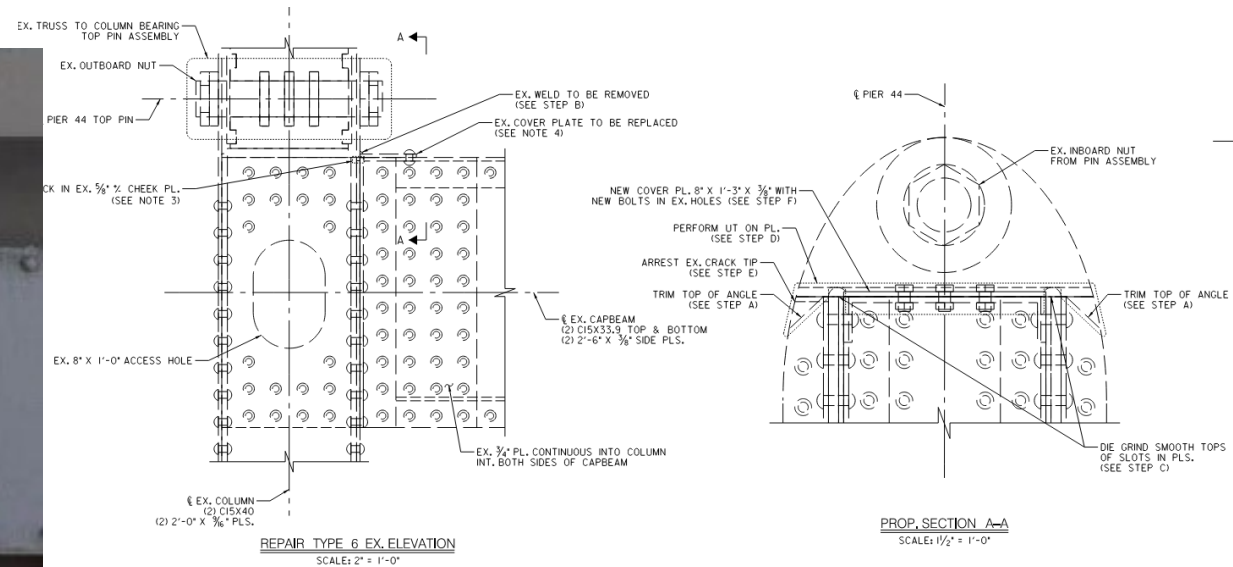
While columns at Pier 44 are a similar configuration a nearby location, they do not match any of the as-built plans.

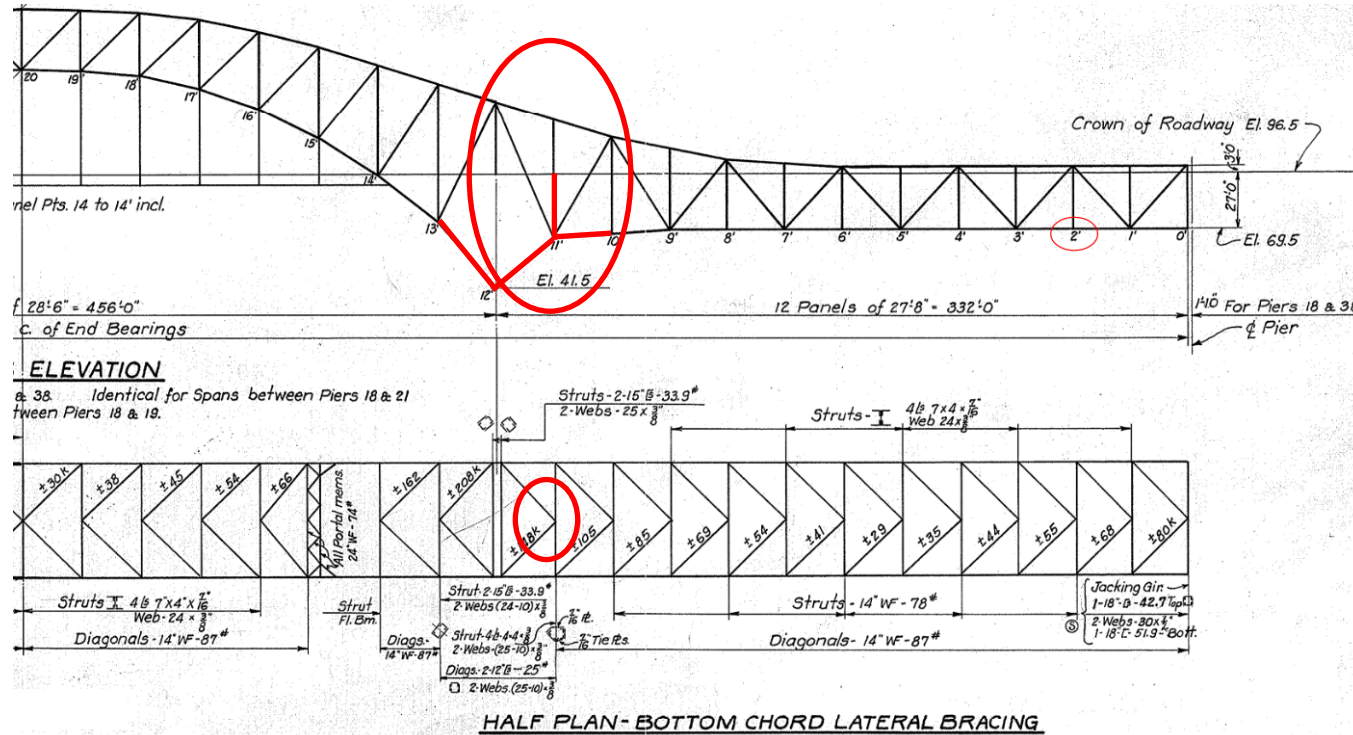
Secondary members with 2 planes converging on a single point, showing 148 kips (+/-) axial loads in bottom laterals

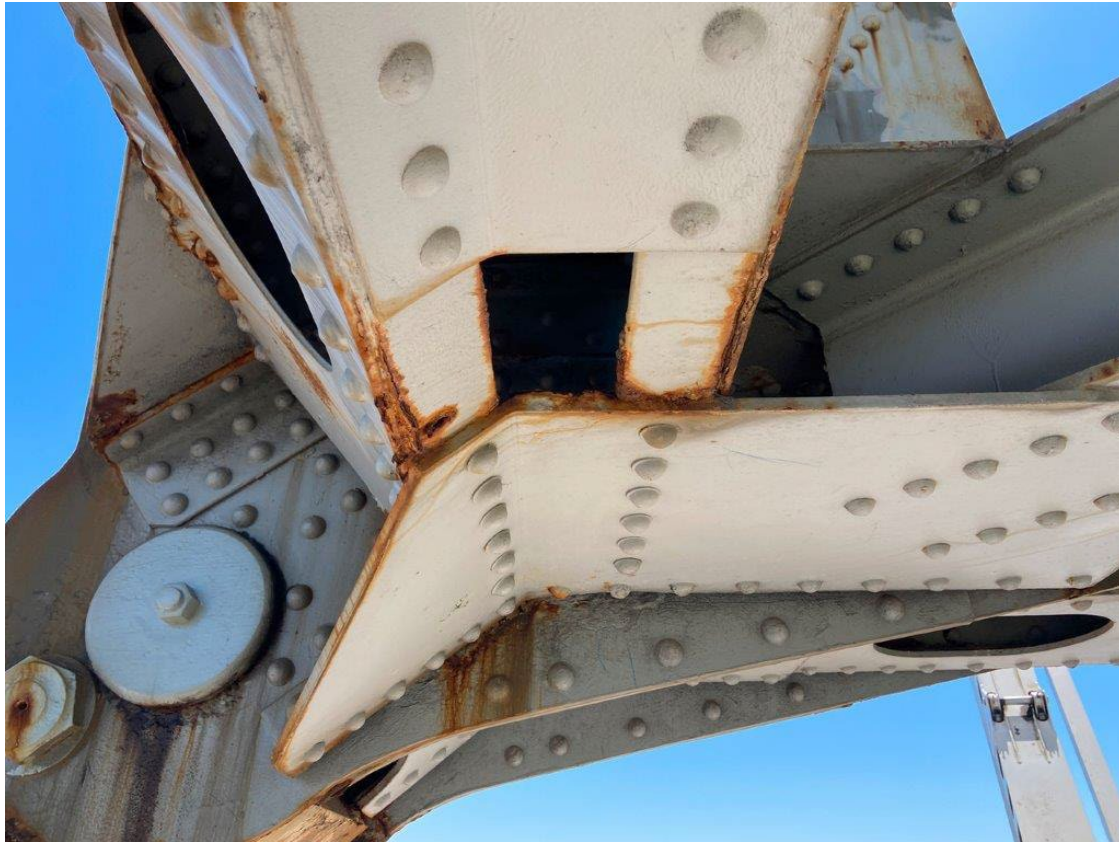
- There is no where to install a temporary strut
- Bracing would take too much time to install and remove given that this is a cleaning and painting contract
- Difficult to justify return on investment

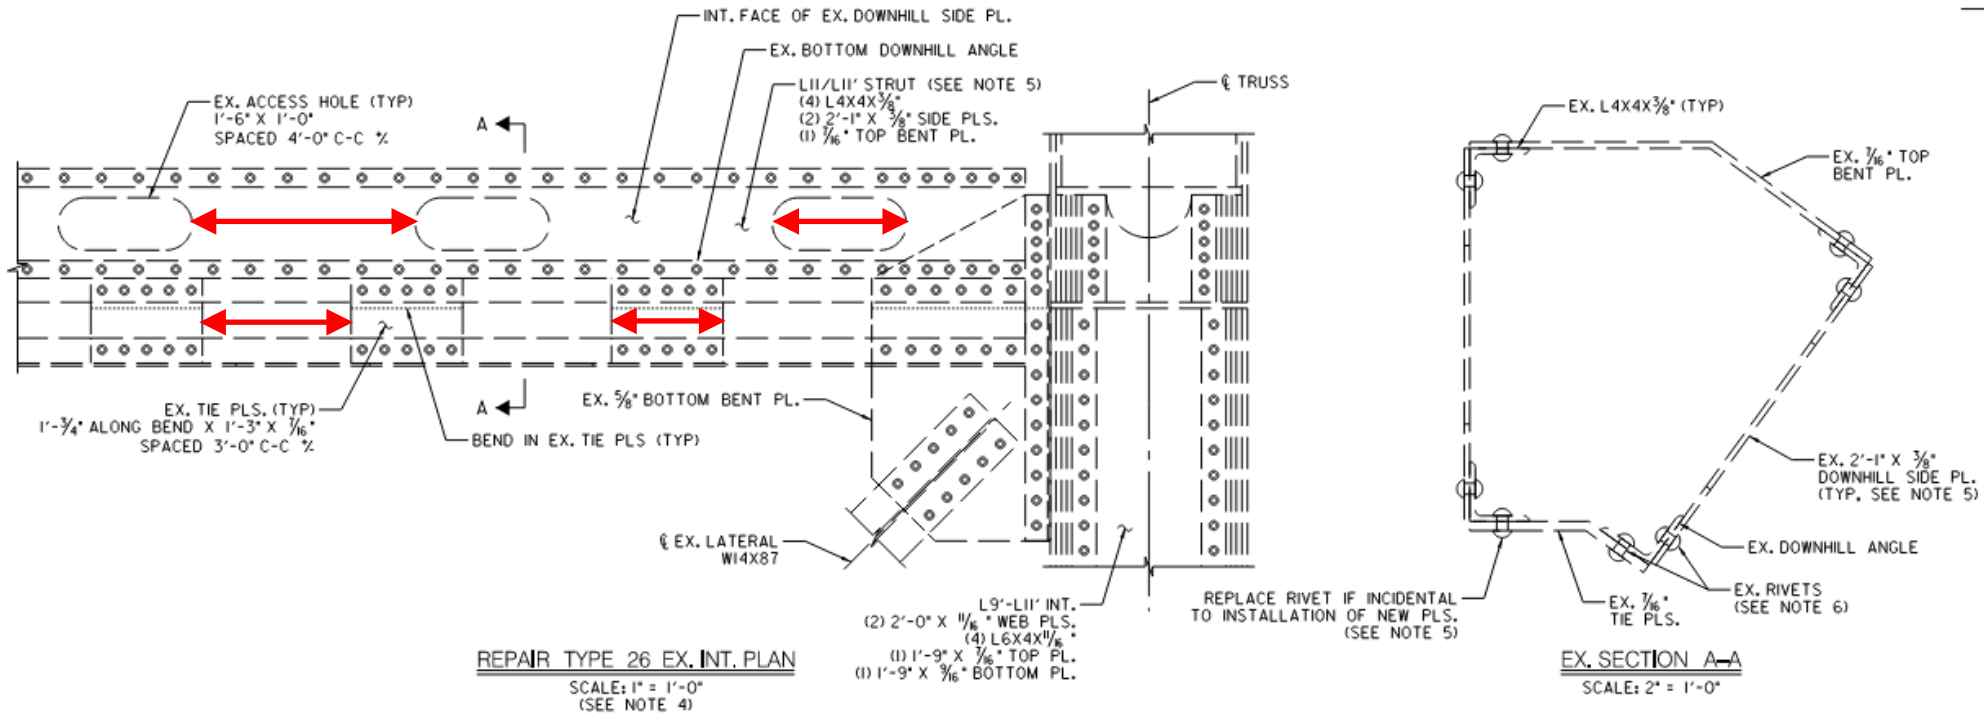
Field verified sizes and spacing of bent plates and holes on web plates since as-built drawings did not show details.

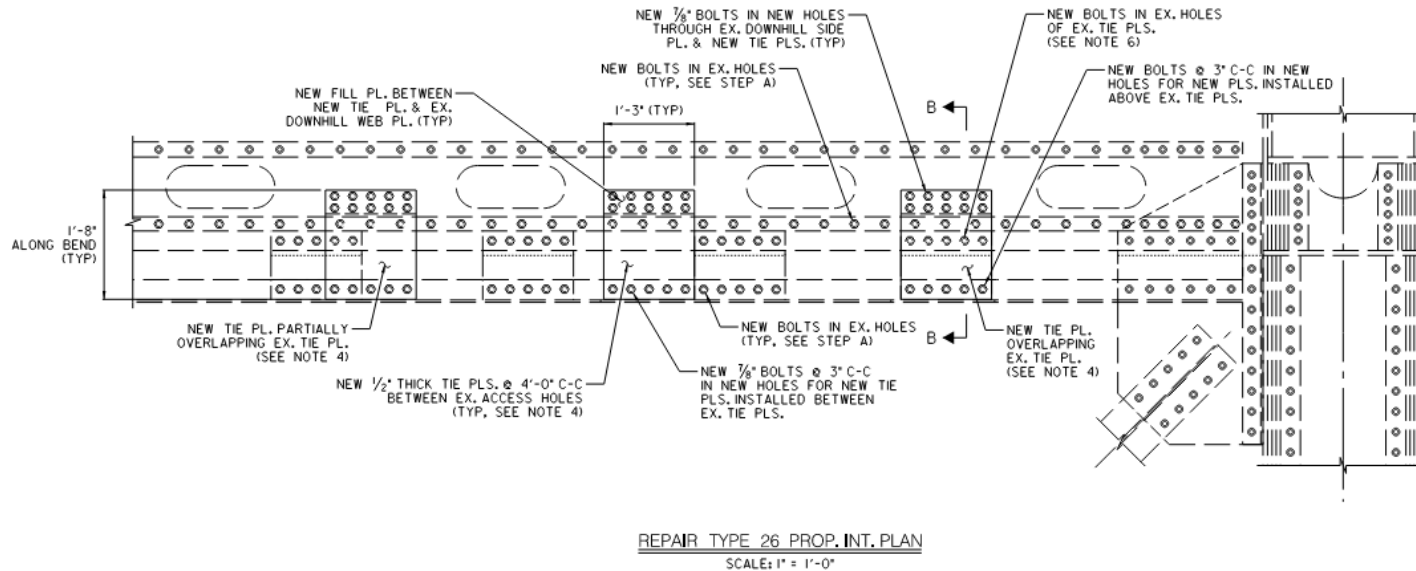
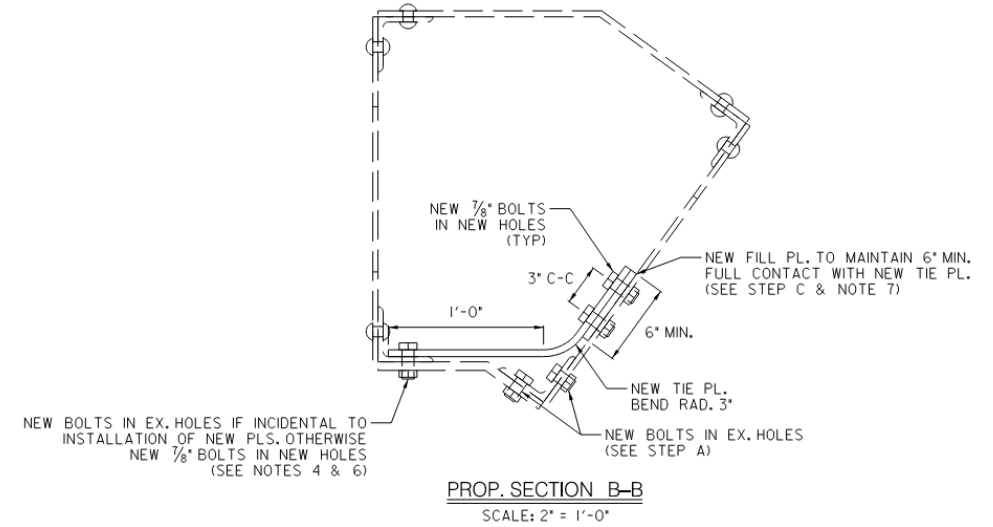
- Replacing existing fasteners between existing web, angle, and tie plates
  - Installing new tie plates that circumvent the angle

- Repair for the bottom strut corrosion and section loss in the L11N to L11S member previous shown
- No temporary bracing required
- Minimal impact on cleaning and painting production
- Replaces existing fasteners and installs new plates and fasteners to augment existing
- Achievable by non-specialized forces in timely and economical manner

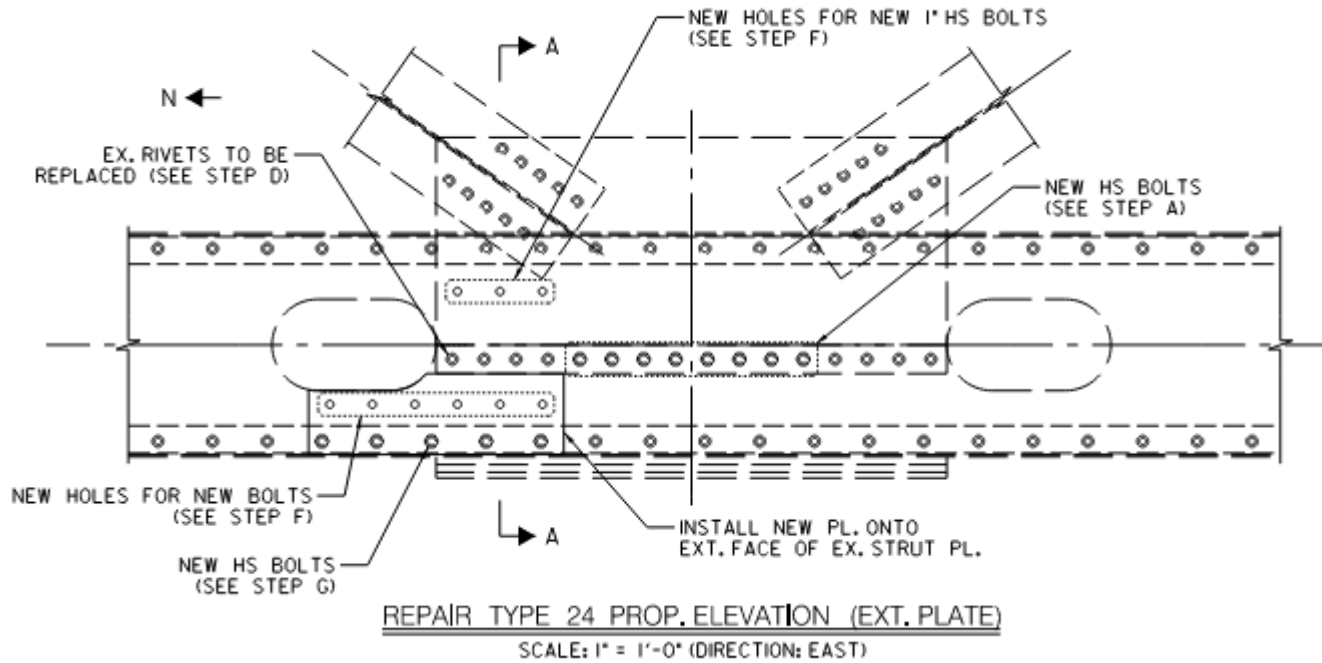
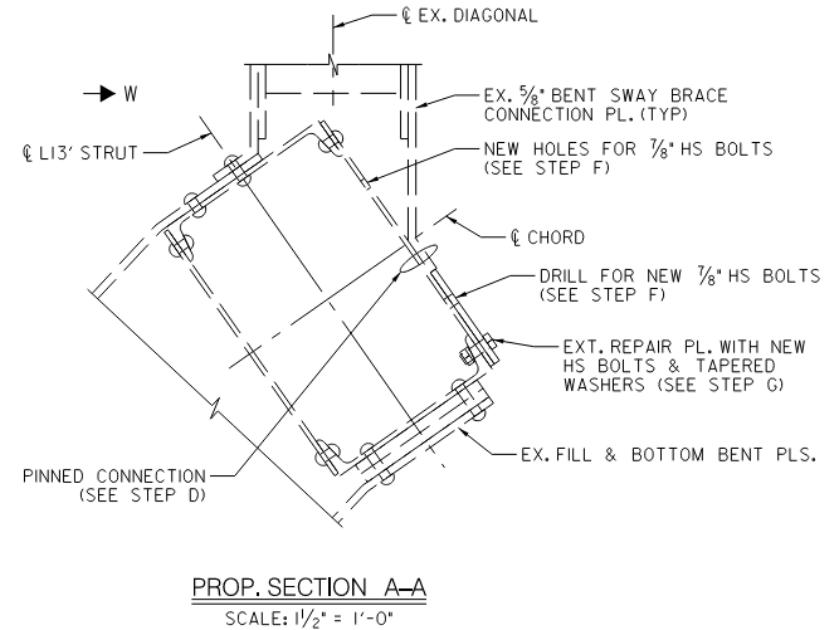
- Replacing existing rivets
- Removing previously welded plates
- Predrilling for new plates

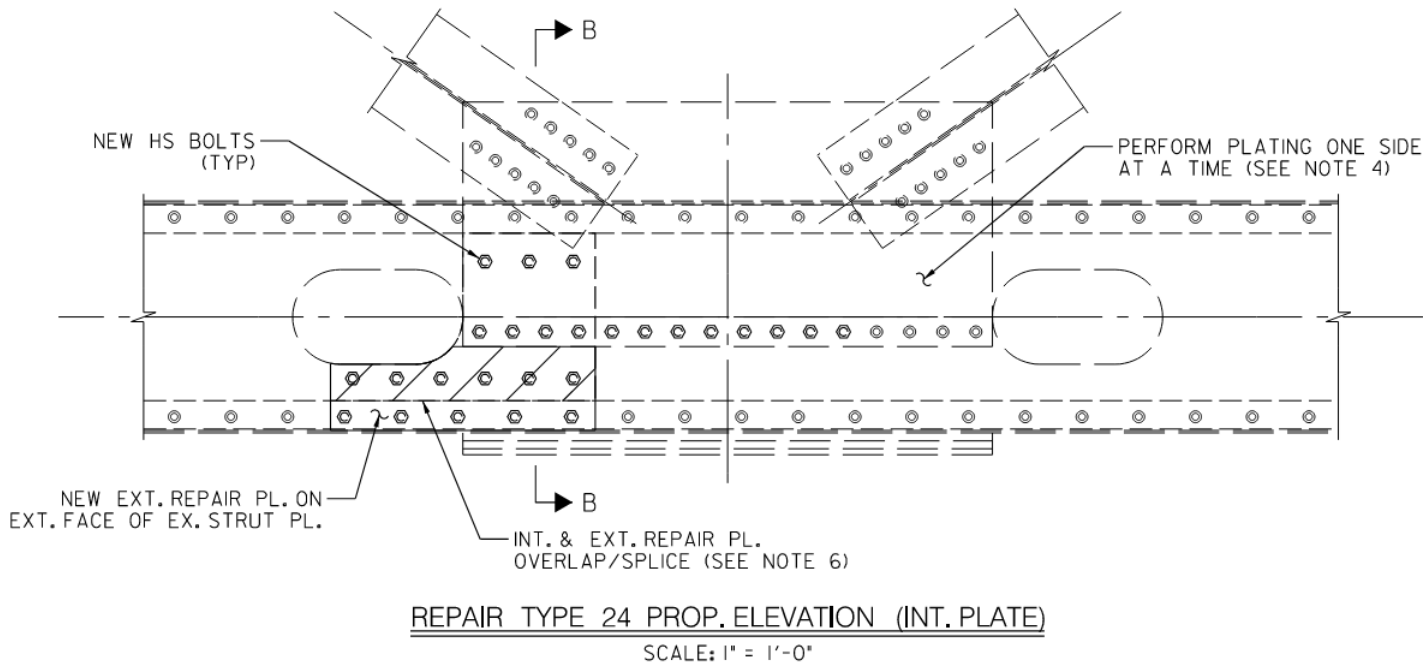
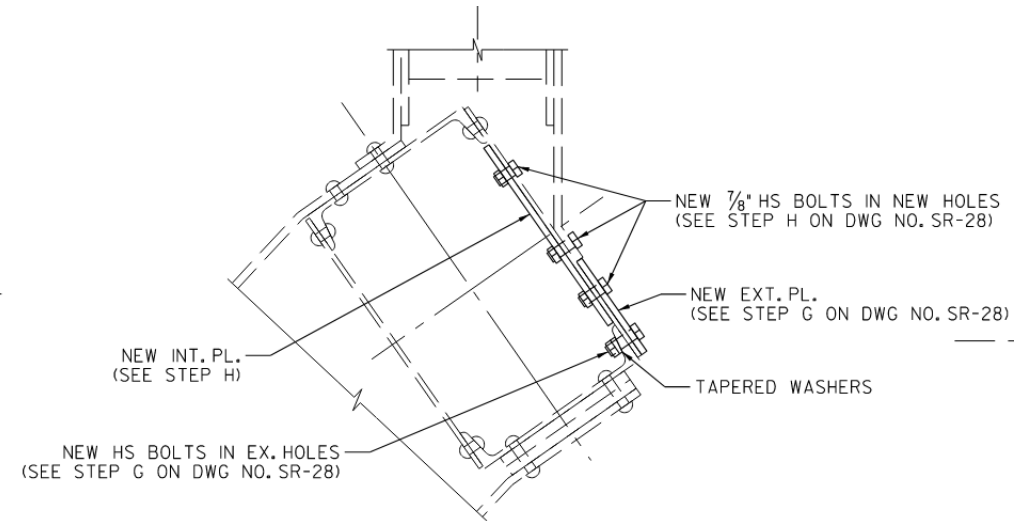
- Installing new exterior and interior plates onto existing and new drilled holes
- Repeat for other side of the connection

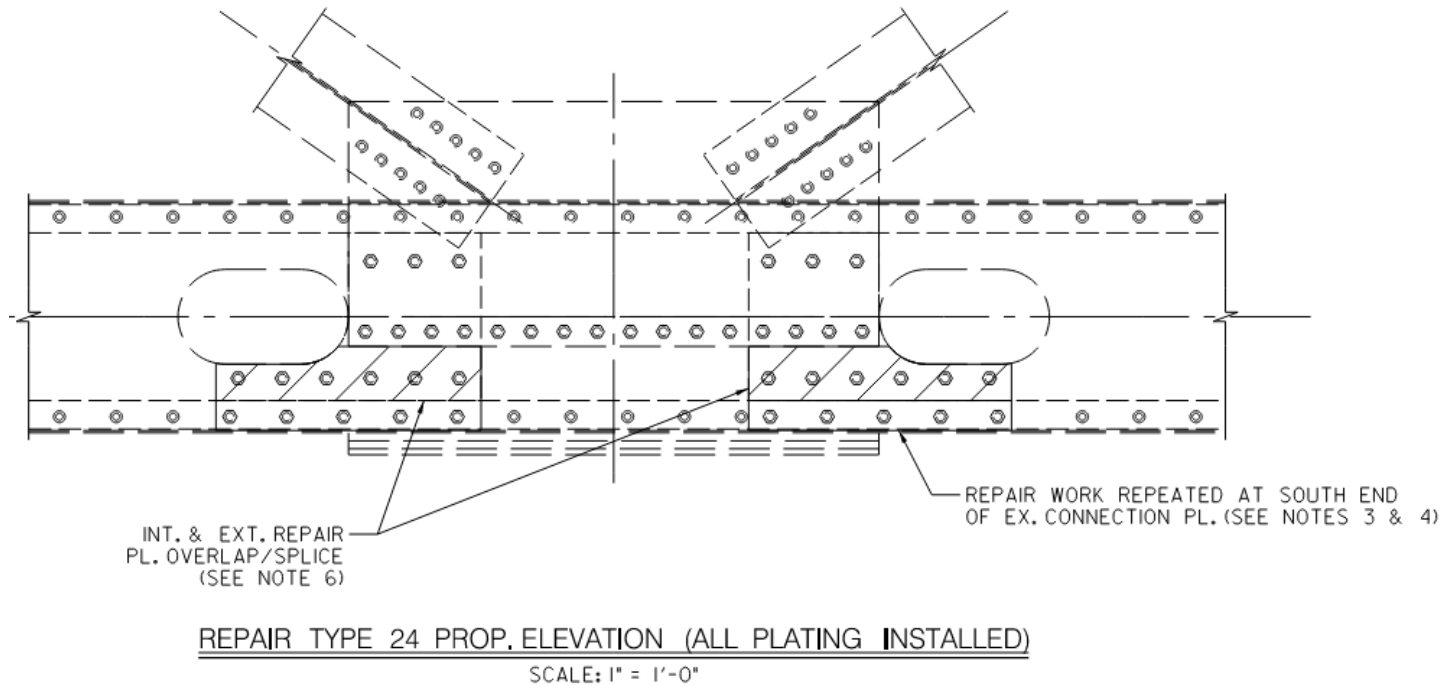
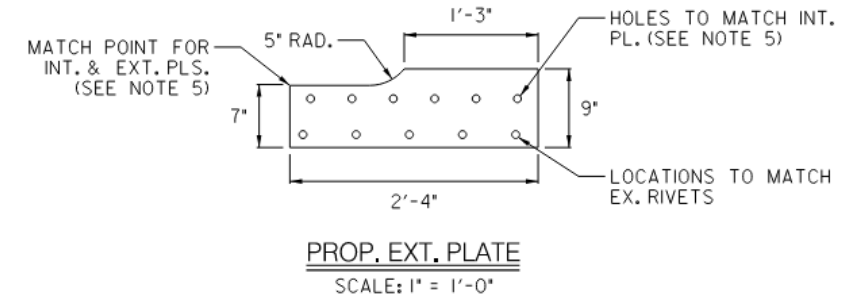
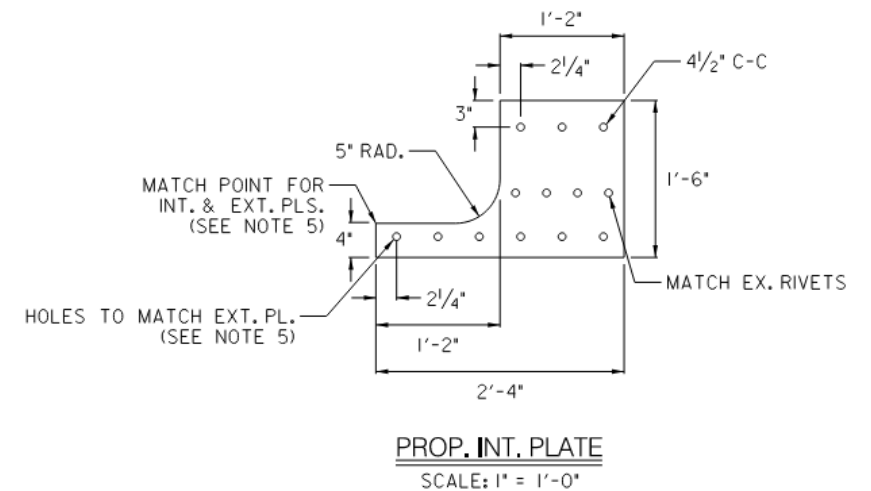
- Sway brace connection plate fasteners replaced
- Previously welded repair removed
- Plating areas with severe section loss
