# Pavement Management Systems Implementation for Local Agencies using Automated Data Collection

2023 Fall Conference at Ashore Resort & Beach Club,  
Ocean City, Maryland

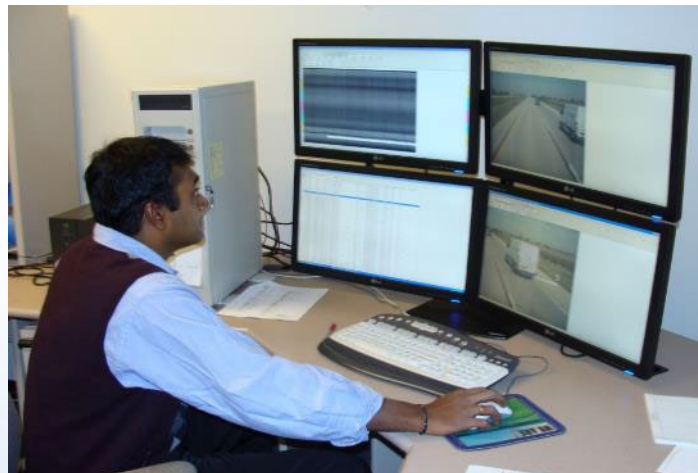
## Semi-Automated

- Combination of automated and manual methods
- Survey performed manually using images collected using automated methods

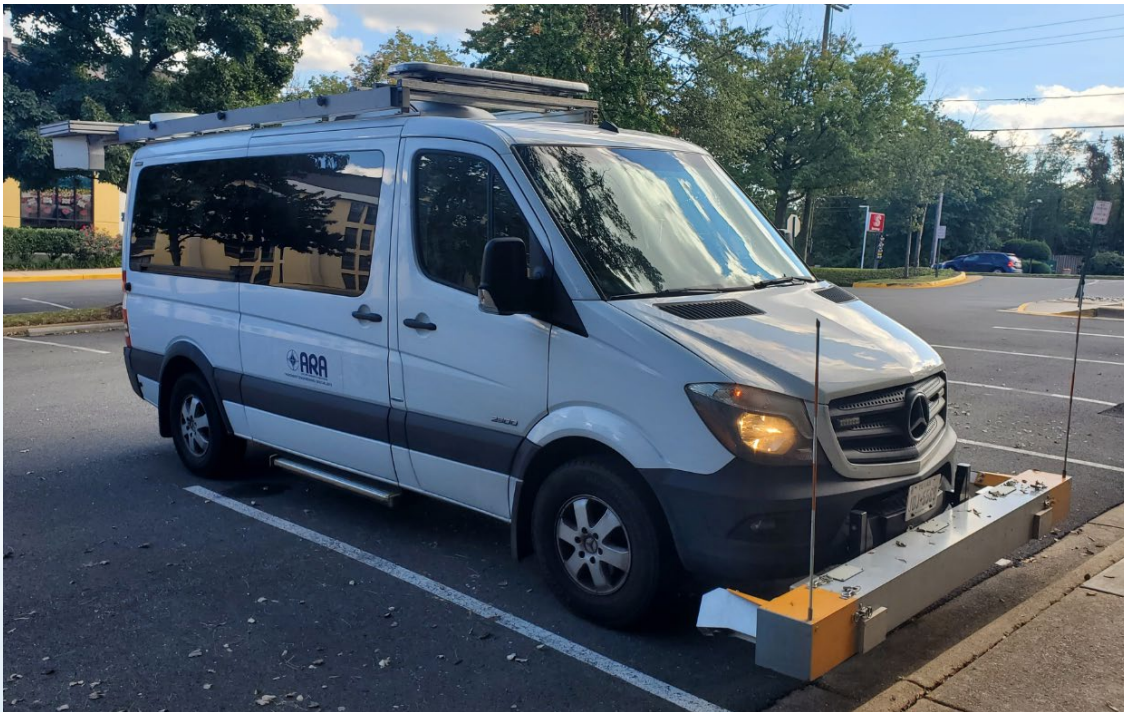
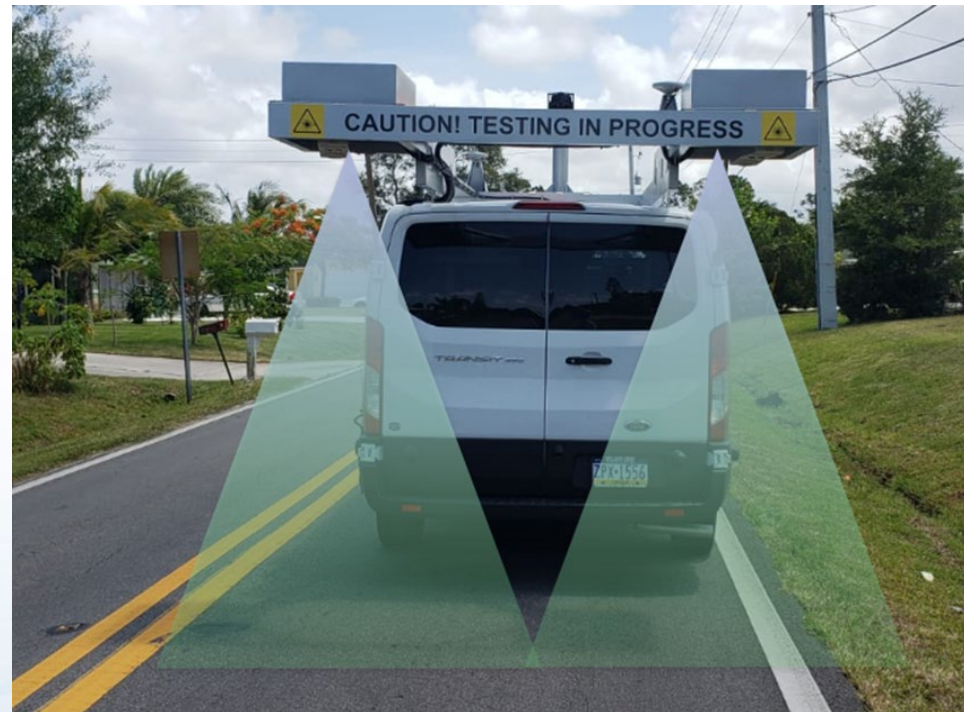
- **LCMS 3D Pavement Imaging** - 1mm cracks are clearly visible; full lane-width coverage
- **Right of Way Imaging** - High resolution, geotagged images
- **IRI, Faulting and Rutting** - High-speed laser profiler is certified at TTI
- **Pavement Geometry** - Cross slope and grade
- **Sub-meter accuracy GPS Coordinates**

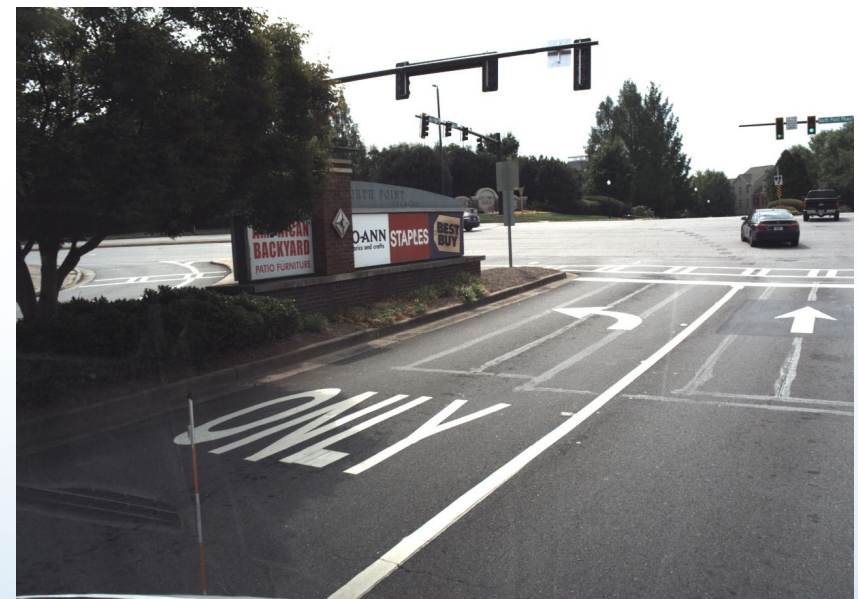
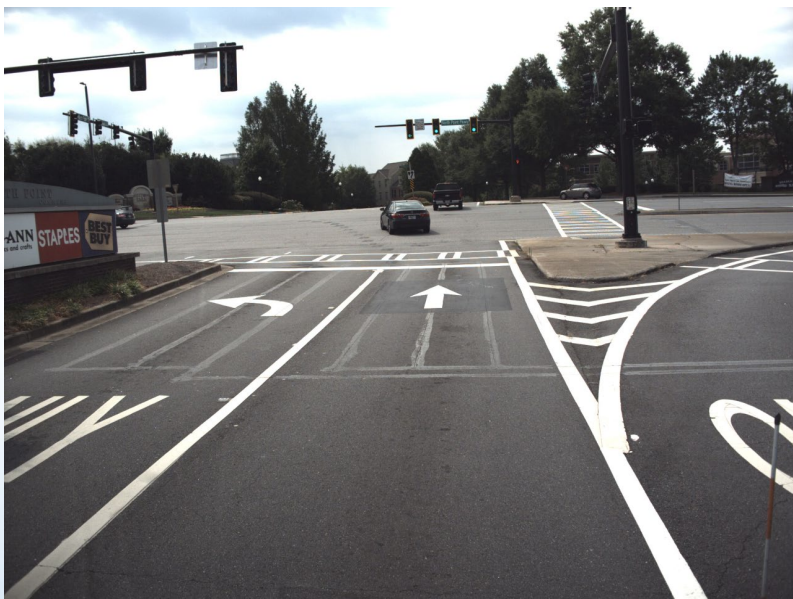
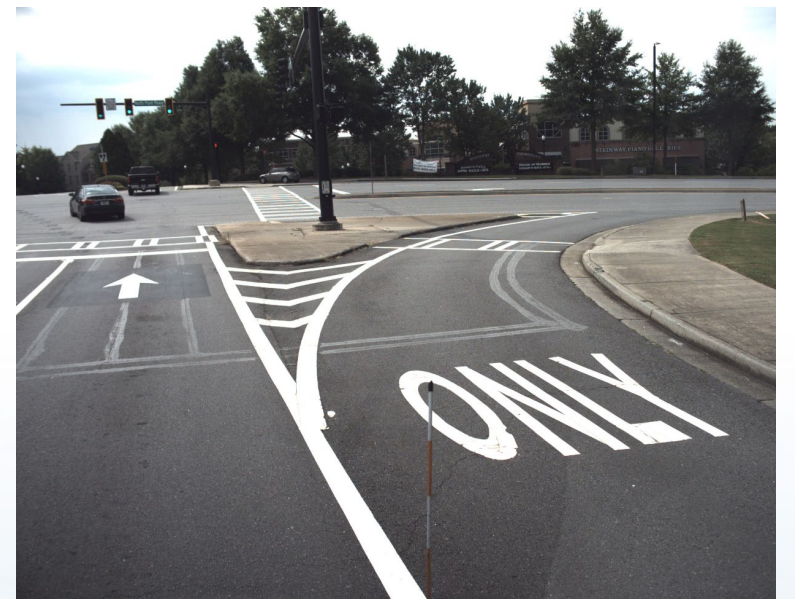
# Example Right of Way Images

Angled Left

Center

Angled Right

Georeferenced Right of Way Images  
(Rear View also Captured)

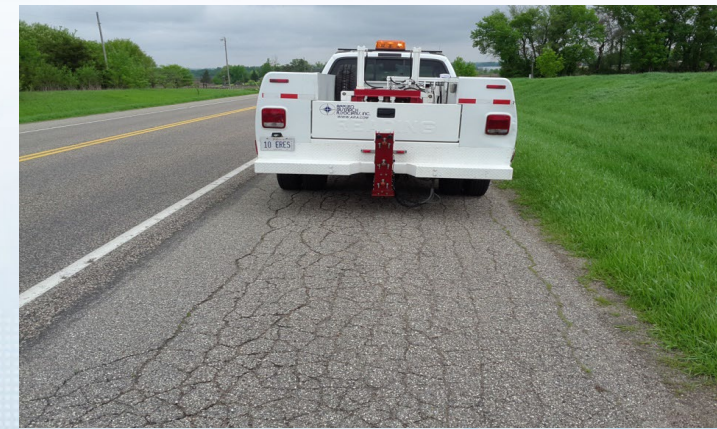
- Falling Weight Deflectometer (FWD)
- Nondestructive testing
- Measures deflection
- Composite Modulus of HMA, Subgrade modulus, & Structural capacity
