2024 Spring Conference at Great Wolf Lodge
Perryville, Maryland
Astoria Bridge Replacement using CM/GC

Charles R Rodrigues

Astoria Bridge Replacement using CM/GC

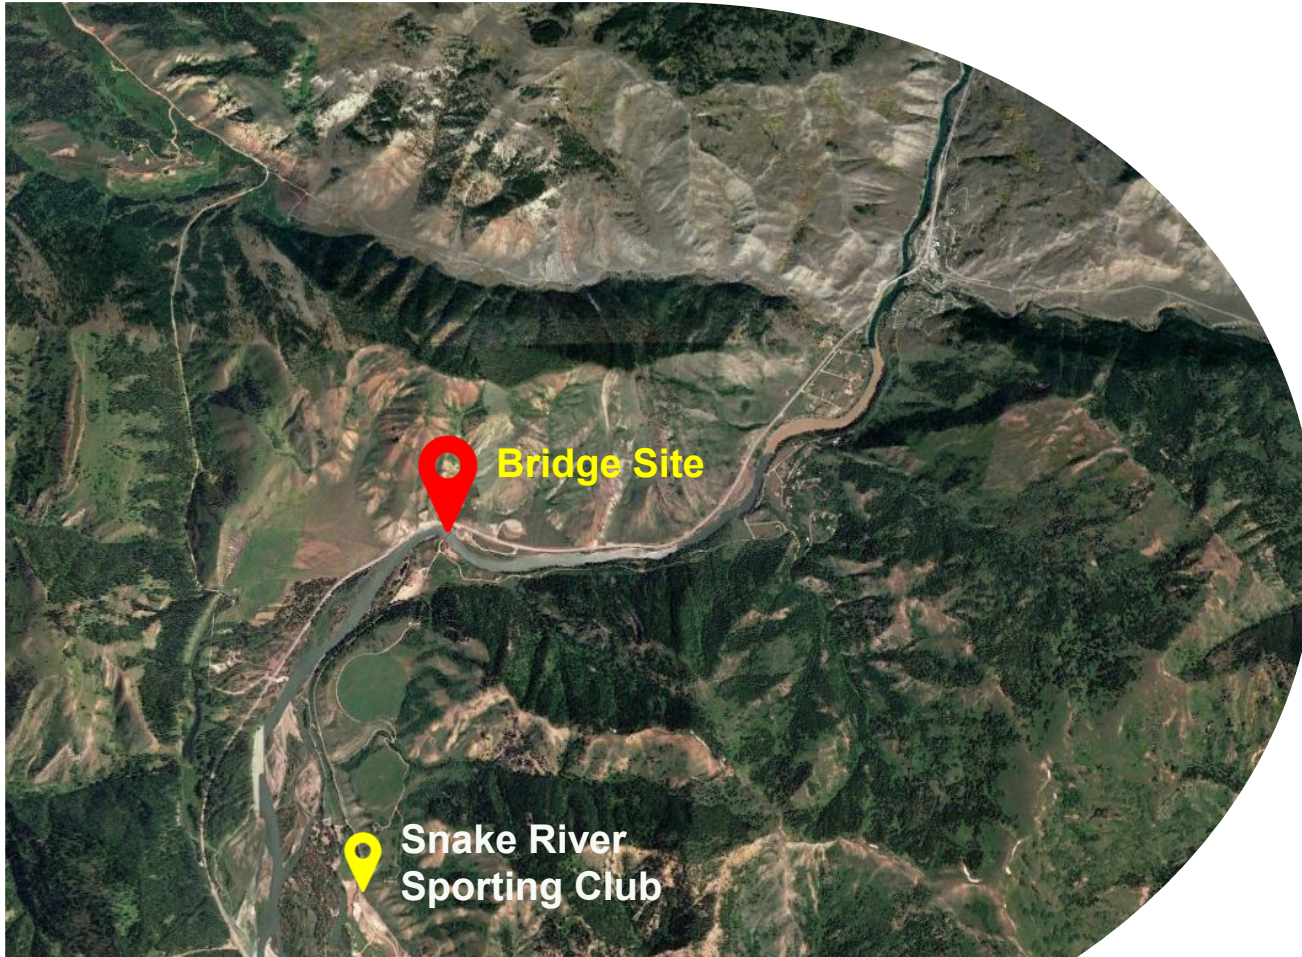
Bridge **location**

- Teton County, WY
- 16 miles south of Jackson
- Bridges over Snake River to provide access to Snake River Sporting Club
- Owned and maintained by Snake River Sporting Club Improvement Services District (SRSC-ISD)

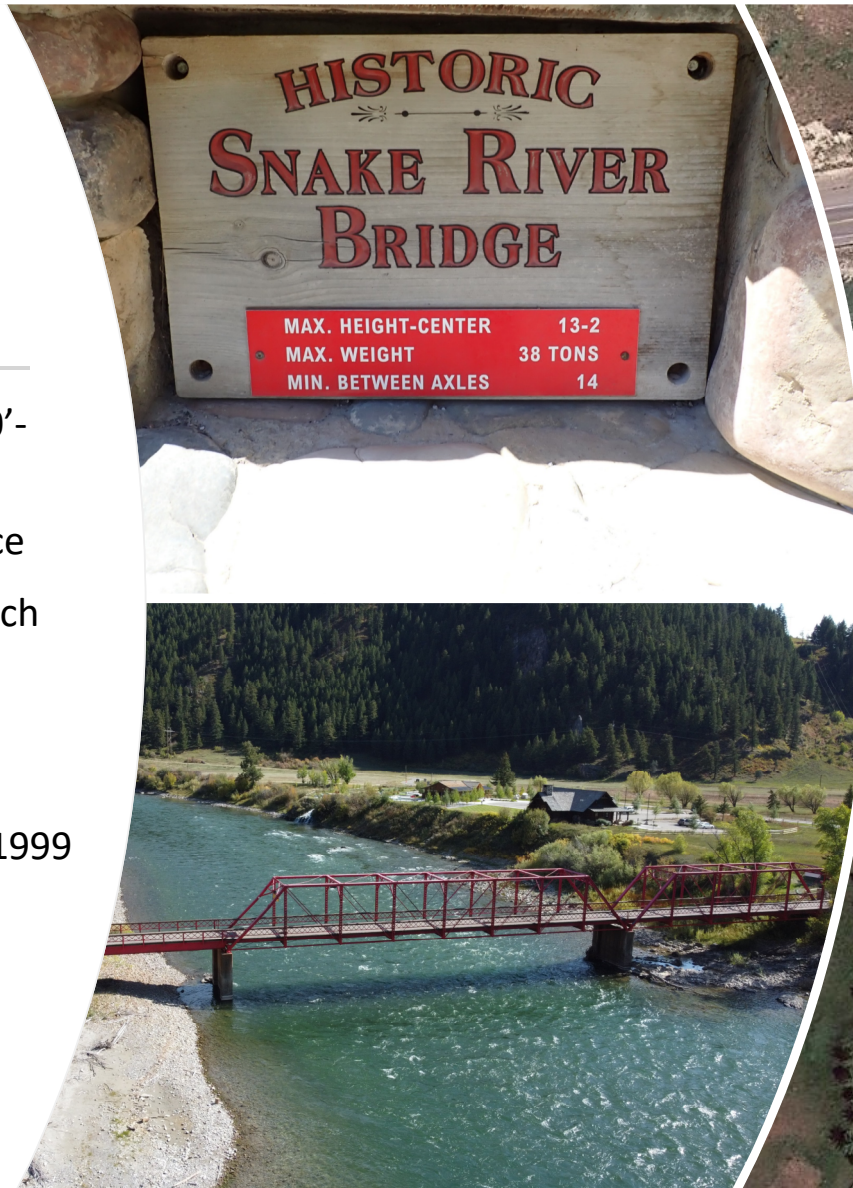
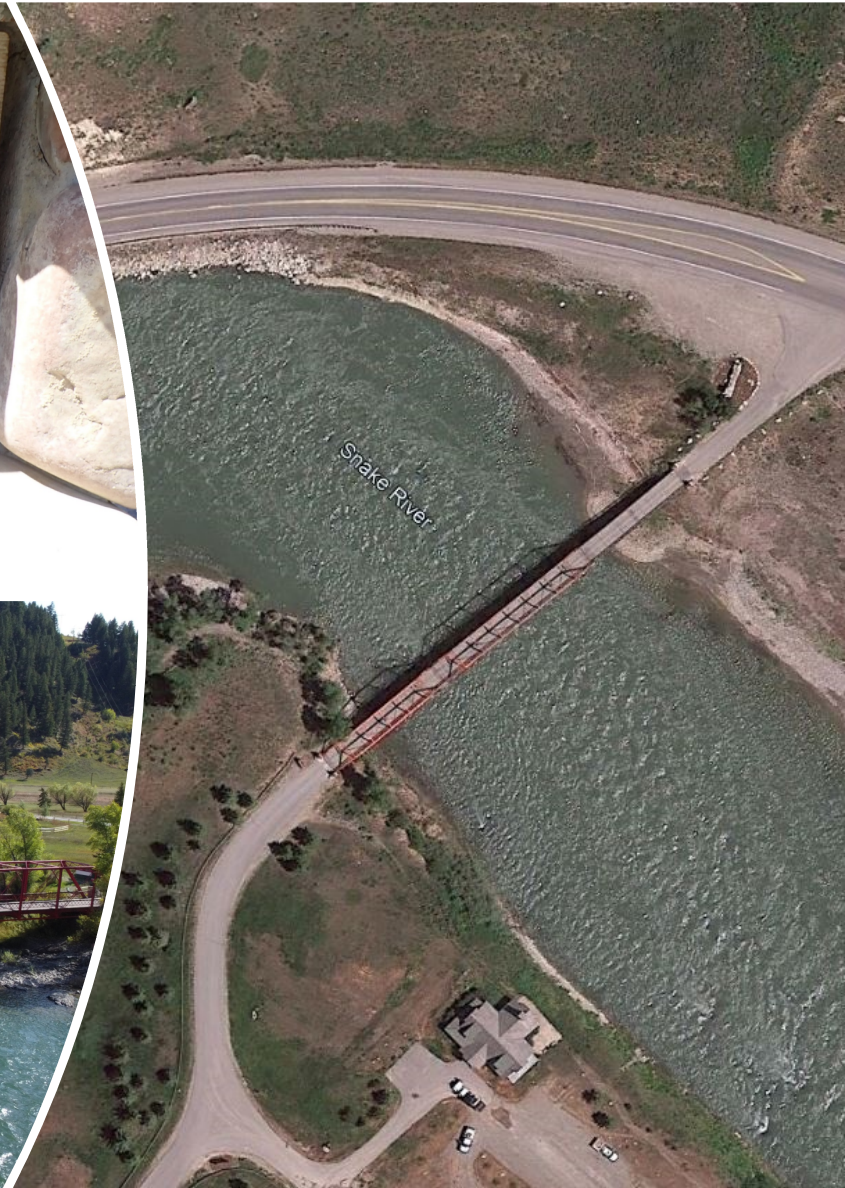
Bridge configuration

- 4 span bridge (113'-150'-48'-48')
- 15ft wide, 13ft clearance
- One lane of traffic in each direction
- Load rated for limited capacity
- Historic Bridge built in 1999

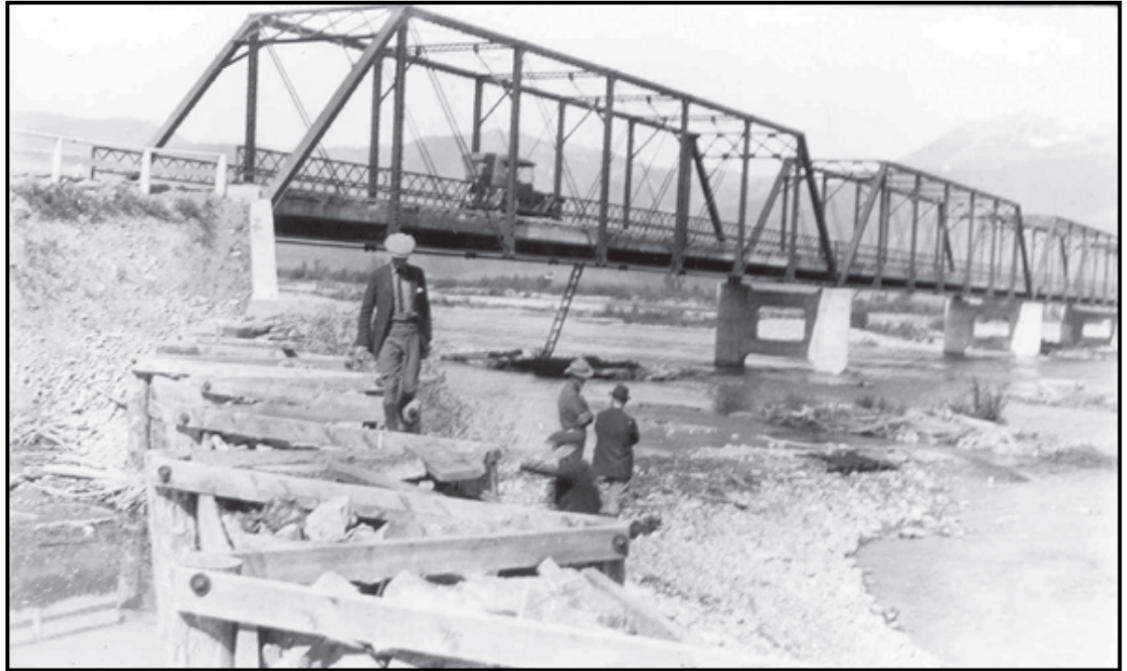
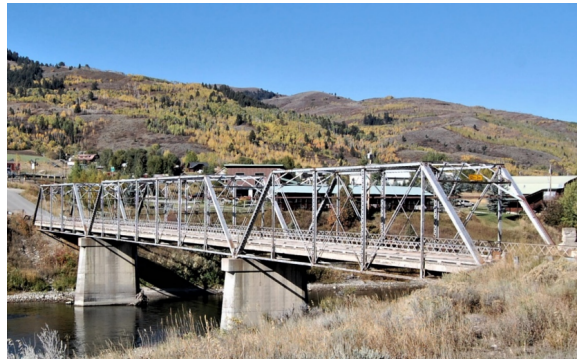
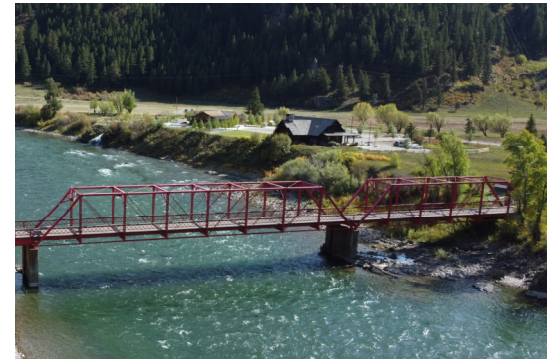
Why Historic!!

- Wilson Bridge – 1915 thru 1922
- 657ft - Longest bridge in WY
- Five 130ft long spans Pin-connected Pratt through truss steel bridge with wooden deck
- Decommissioned in Oct 1959.
- Reassembled as Swinging Bridge (3 spans) and Astoria Bridge (2 spans)
- Swinging Bridge – 1959
- Astoria Bridge – 1999

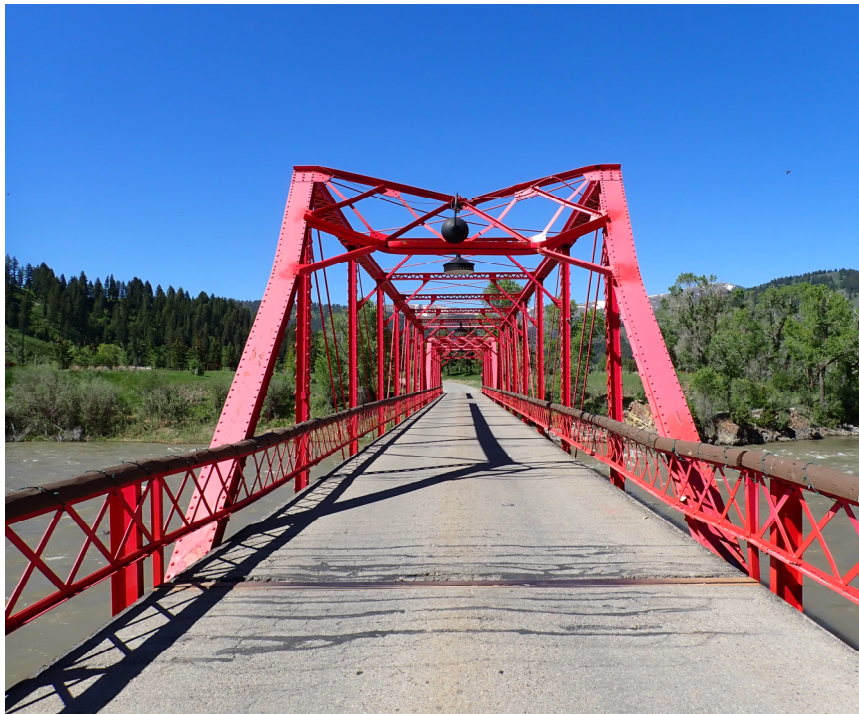
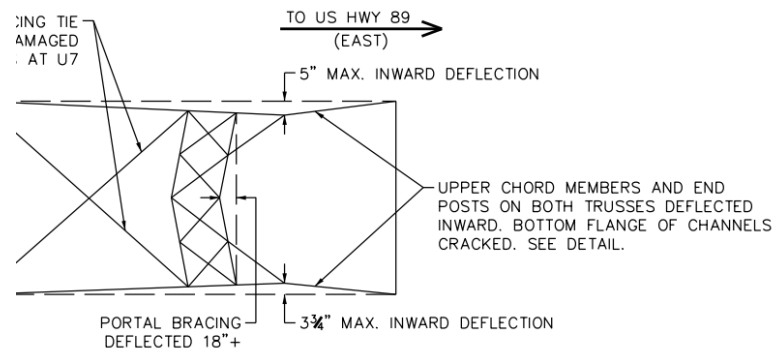
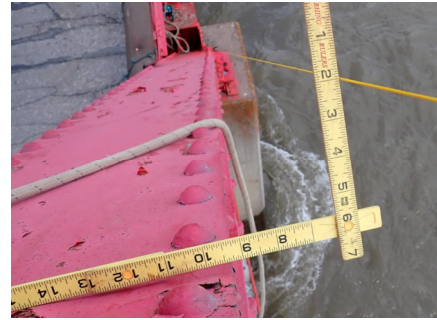
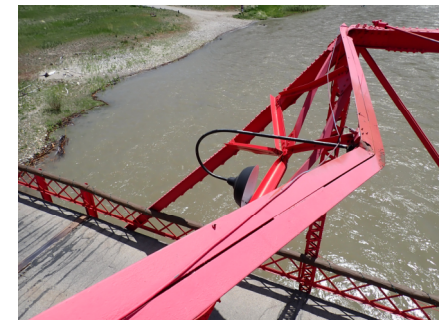
Collision Damage

June 2021

- Issues discovered
 - Bottom chords for main span were undersized during re-assembly in 1999
 - Truss configuration did not match original geometry. 7 panel truss was re-configured to 6 and 8 panel
 - Original load rating of 38 tons should have been 27 tons
- Collision damage – repeat offenders
 - Vertical clearance not sufficient for current needs
 - Costly and highly technical repairs
 - Detour through restricted and poorly maintained route
- Heavy construction vehicles needed access for current and future growth
- Speed posted to allow reduced load rating by limiting impact
- Load rating dropped from 38 tons to 5 tons

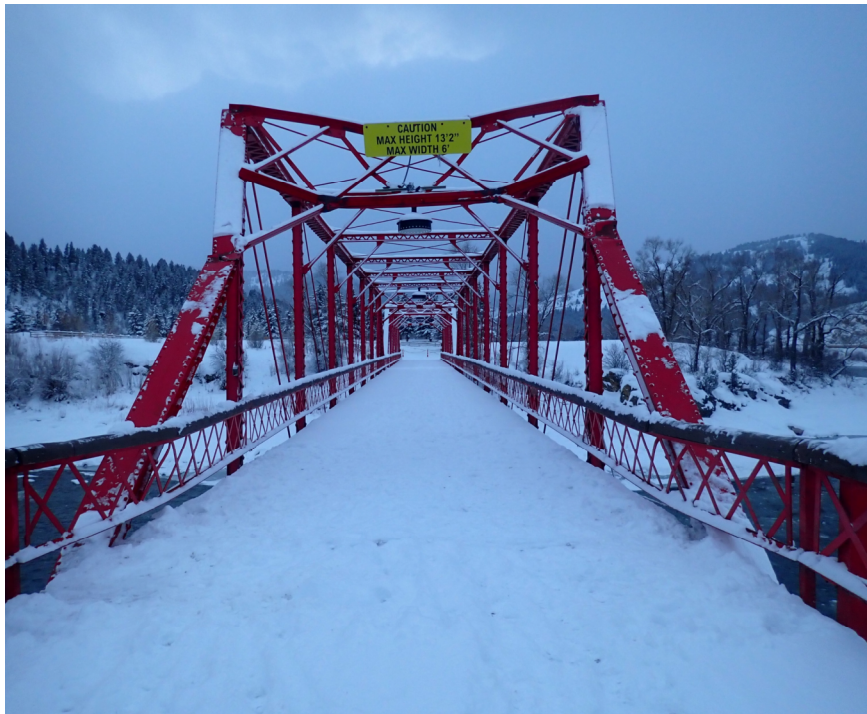
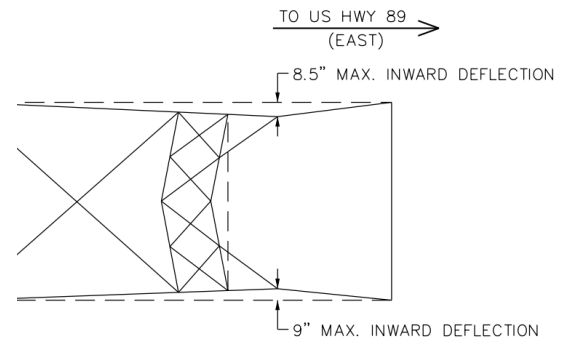
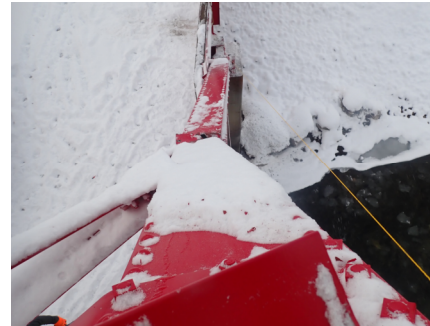
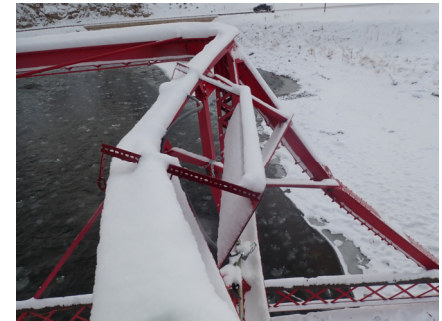
Collision Damage

December 2022

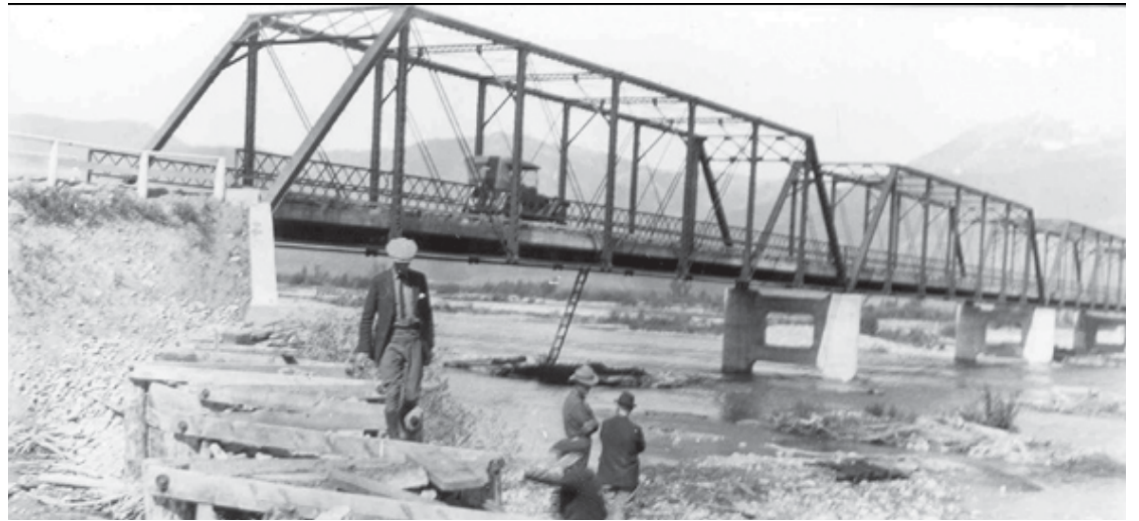
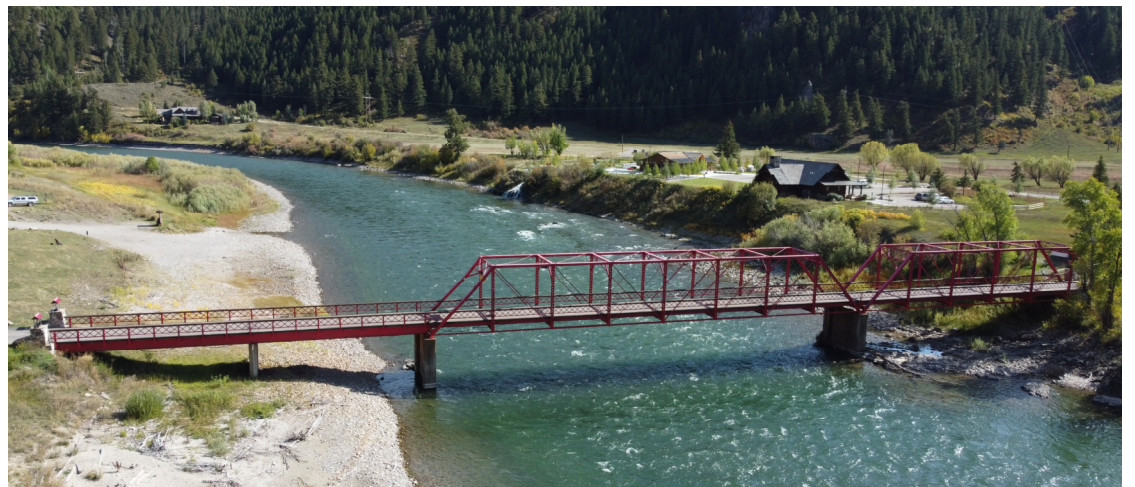
Preserving **History**

- Truss changed from 7-panel to 6/8 panel truss during relocation
- Re-use existing lattice railing
- Match overall bridge aesthetic
 - Truss bridge
 - Red color
 - Narrow-tunnel like feeling
- Historical monument

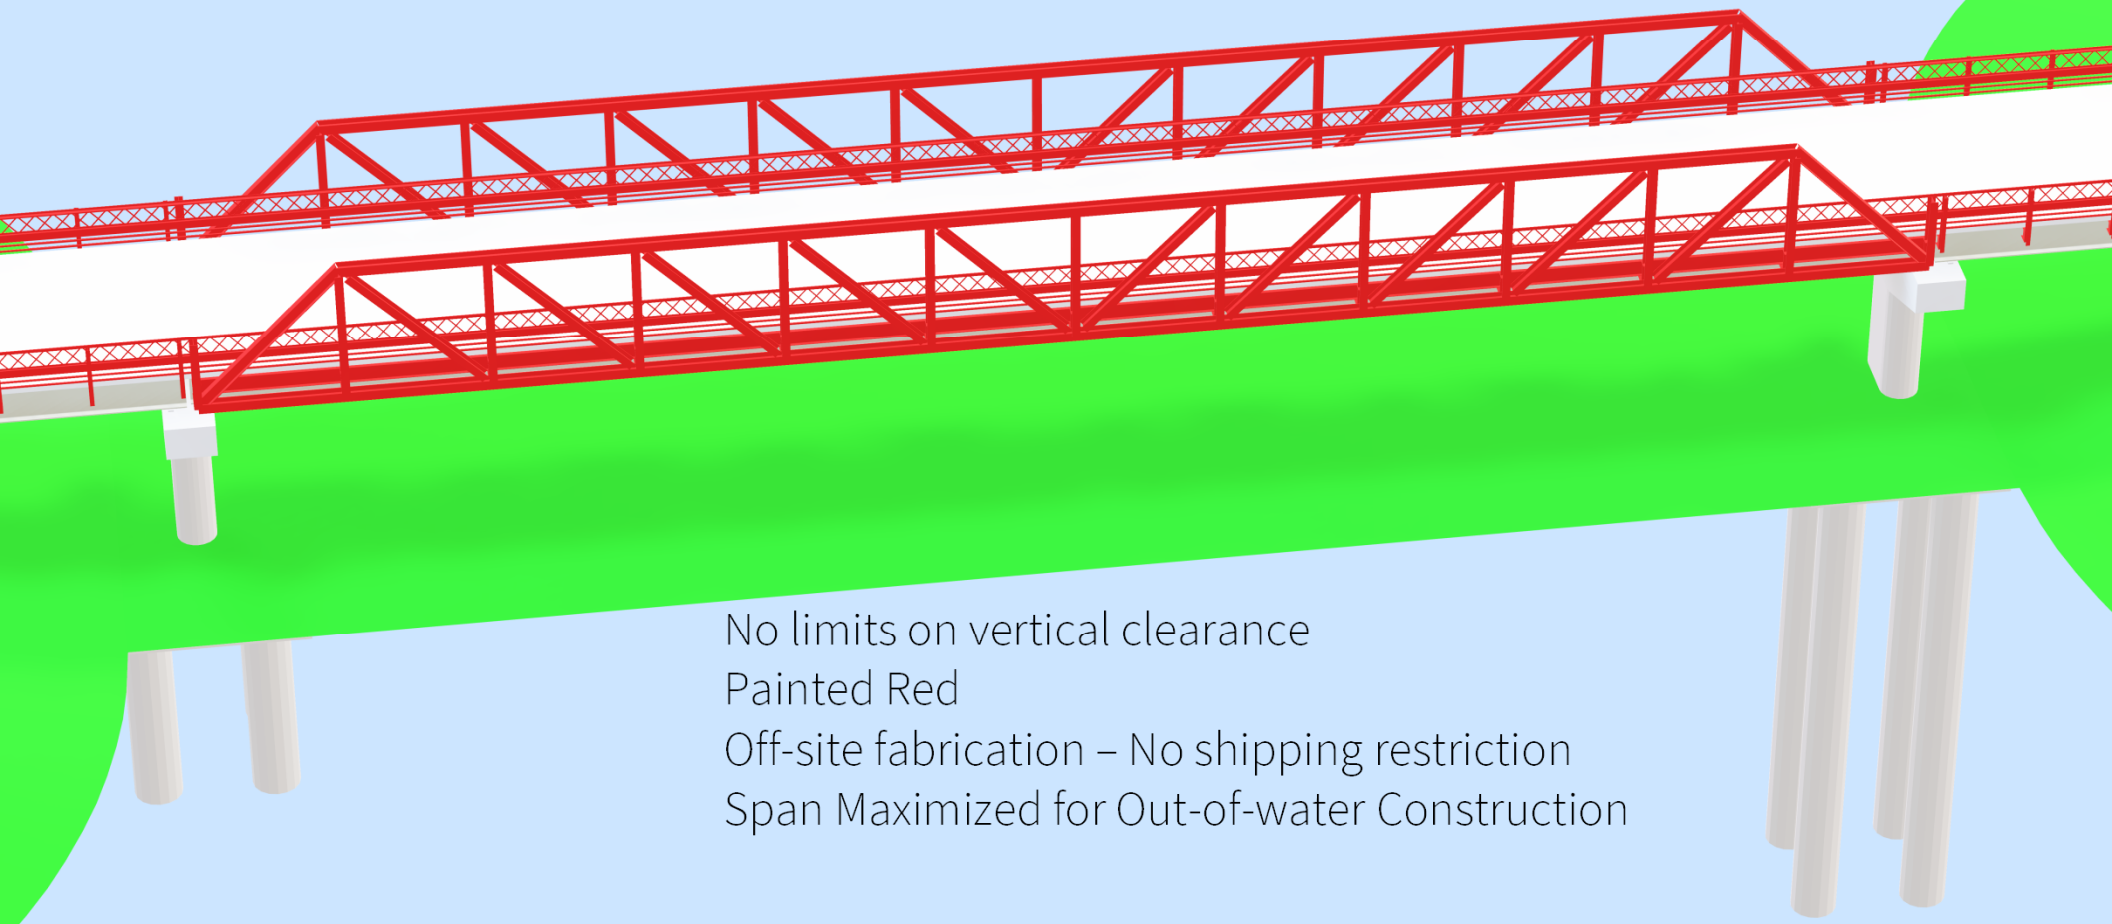
Pony Truss

No limits on vertical clearance
Painted Red
Off-site fabrication – No shipping restriction
Span Maximized for Out-of-water Construction

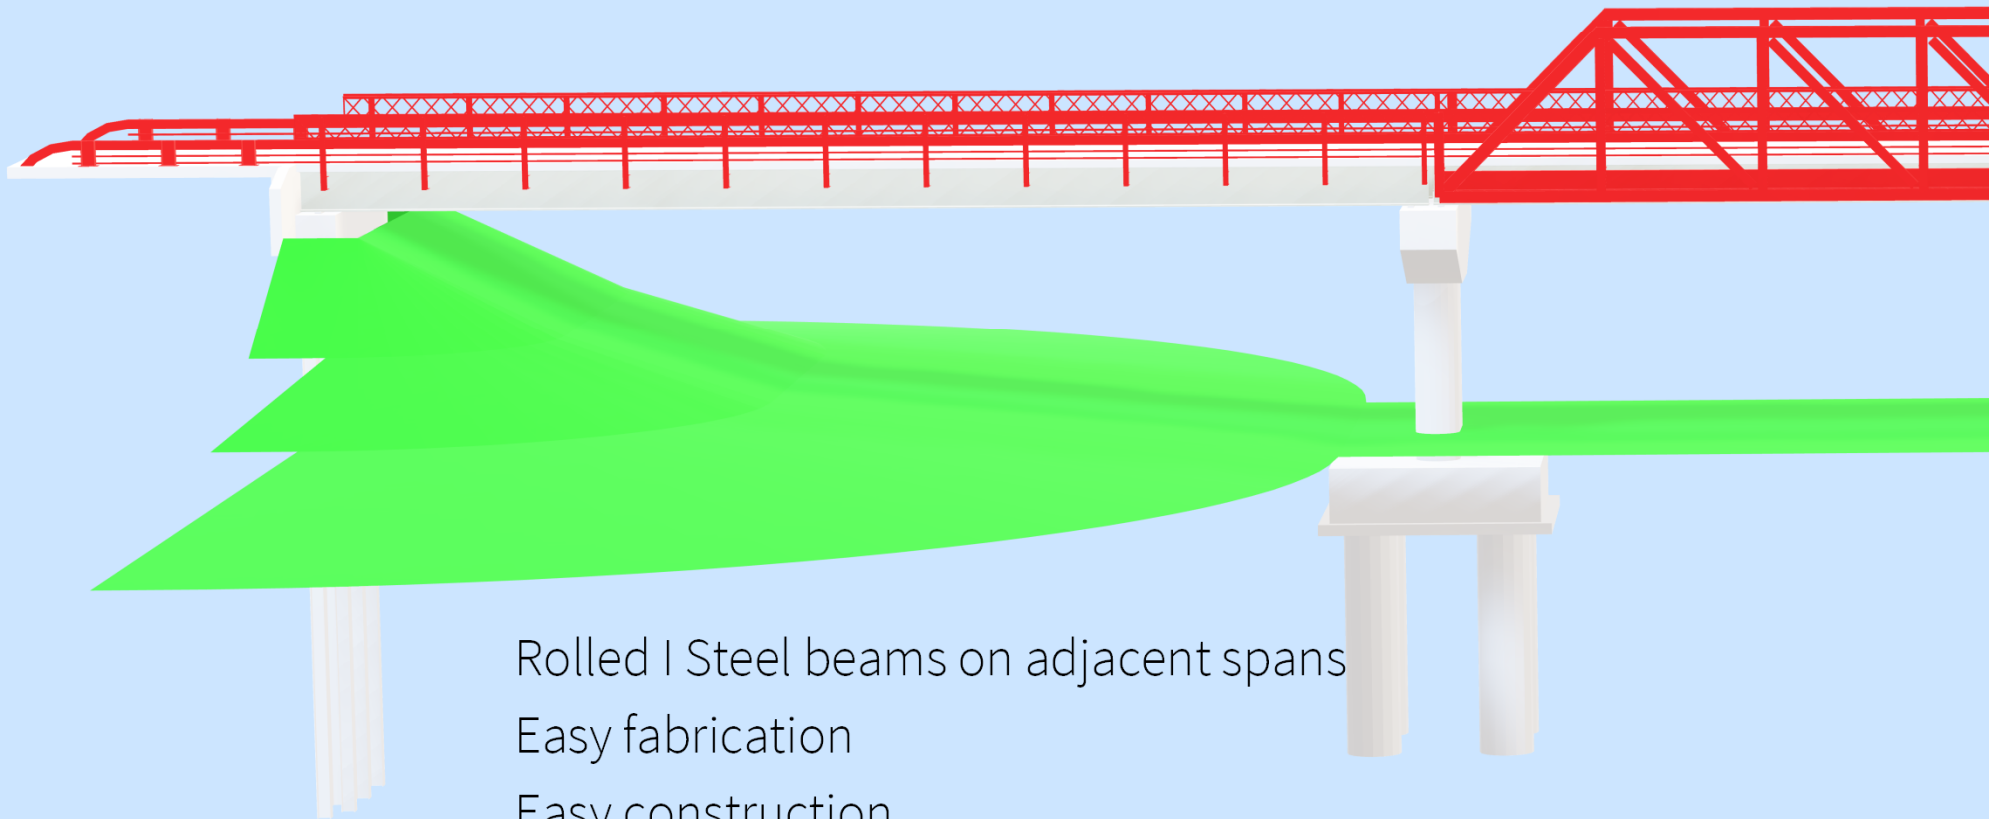
End Spans

Rolled I Steel beams on adjacent spans
Easy fabrication
Easy construction

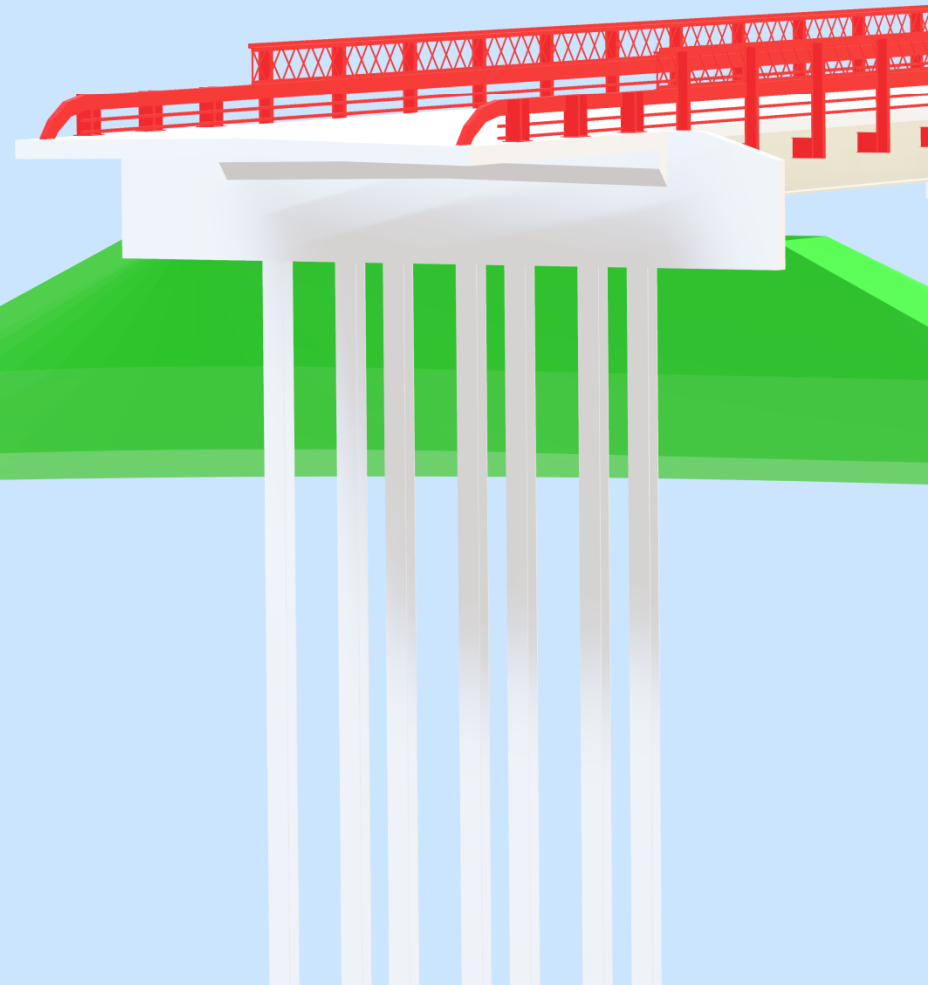
Traditional Abutments

Concrete Abutments
2 rows of Steel H Piles
Predrilled Holes for drivability

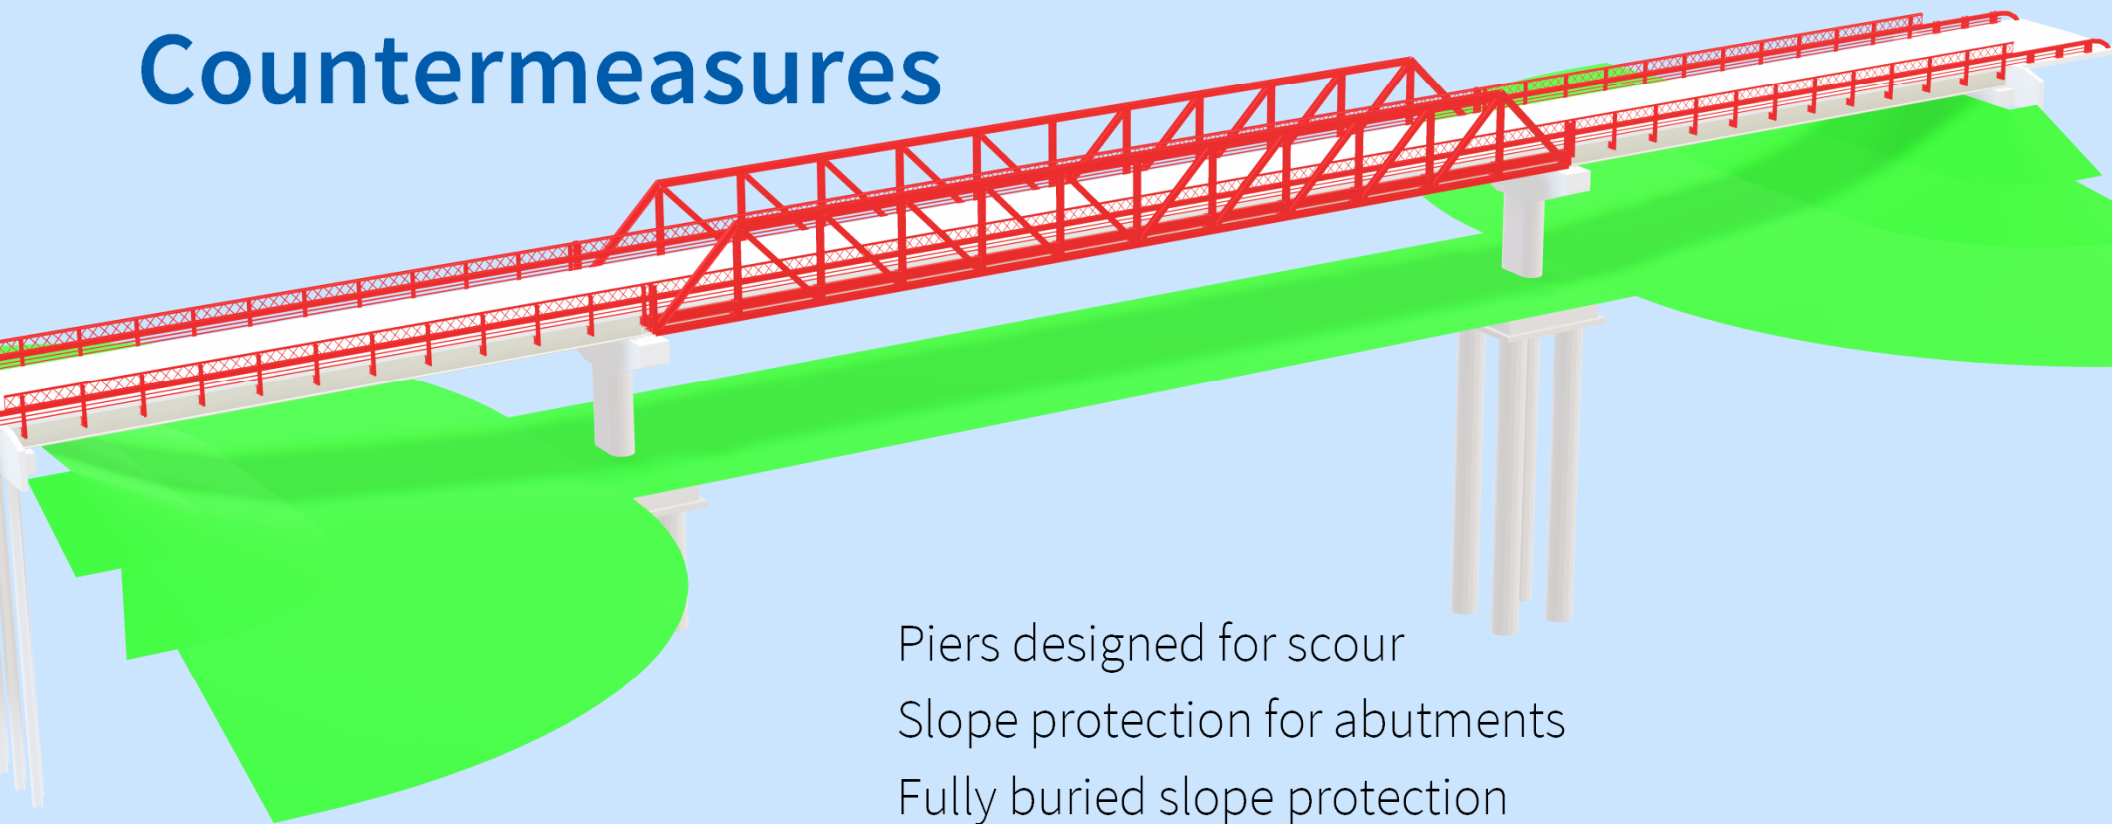
Scour Countermeasures

Piers designed for scour
Slope protection for abutments
Fully buried slope protection
