2023 Fall Conference, Ocean City, Maryland

**High Hazard Dam Rehabilitation Case Study:
Gerwig Lane Dam, Howard County, Maryland**

B. Gregory Adolph, P.E.

September 29, 2023

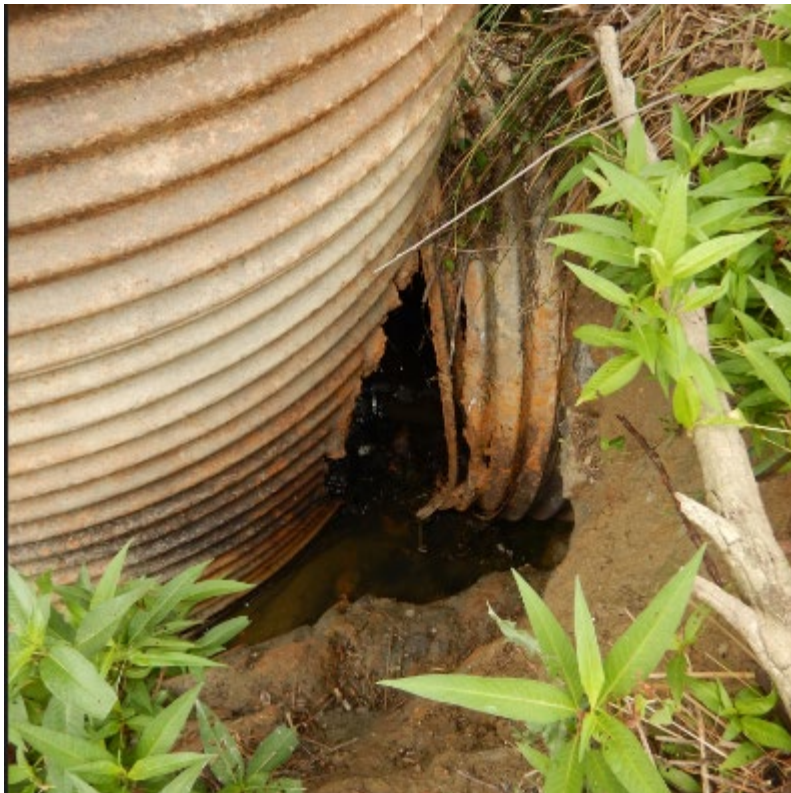
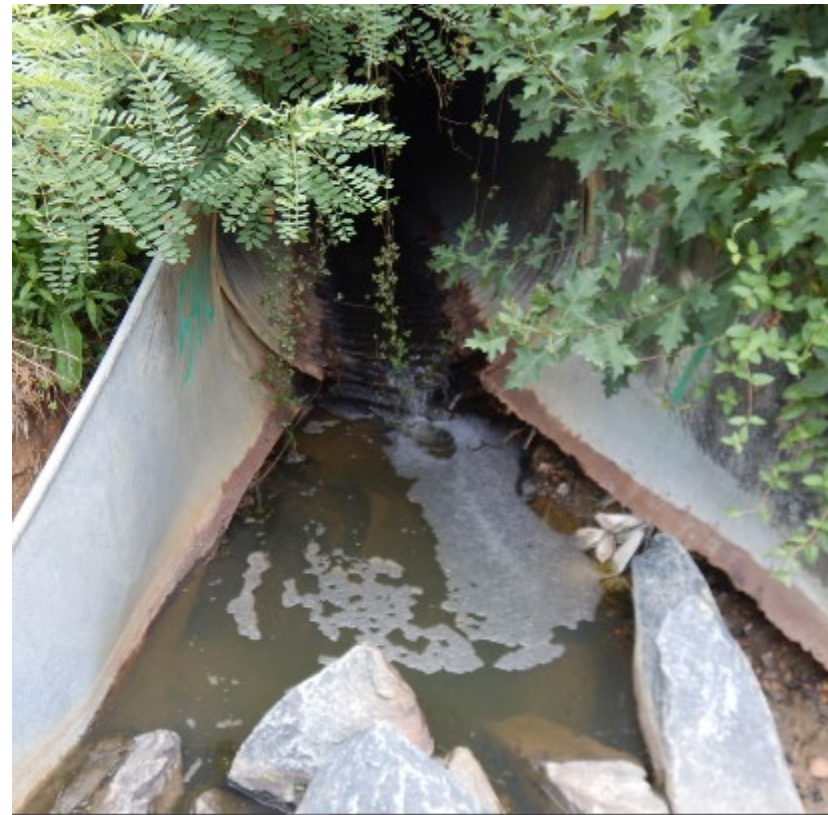
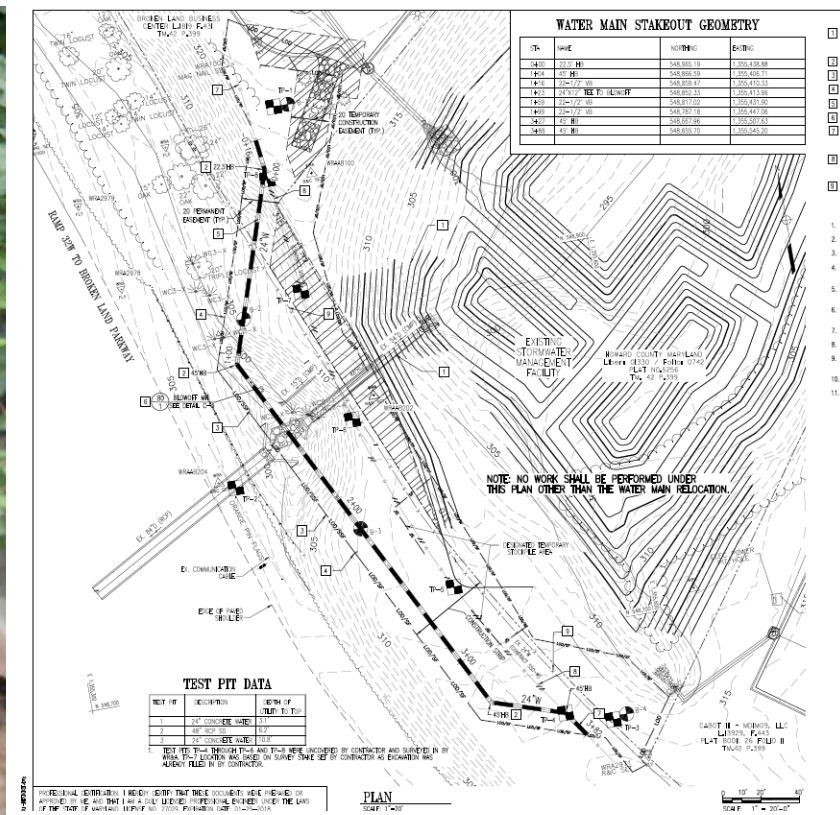
INSPECTION AND DESIGN HISTORY

- Ongoing remedial repairs to mitigate embankment erosion
- Utility relocated from embankment in 2016

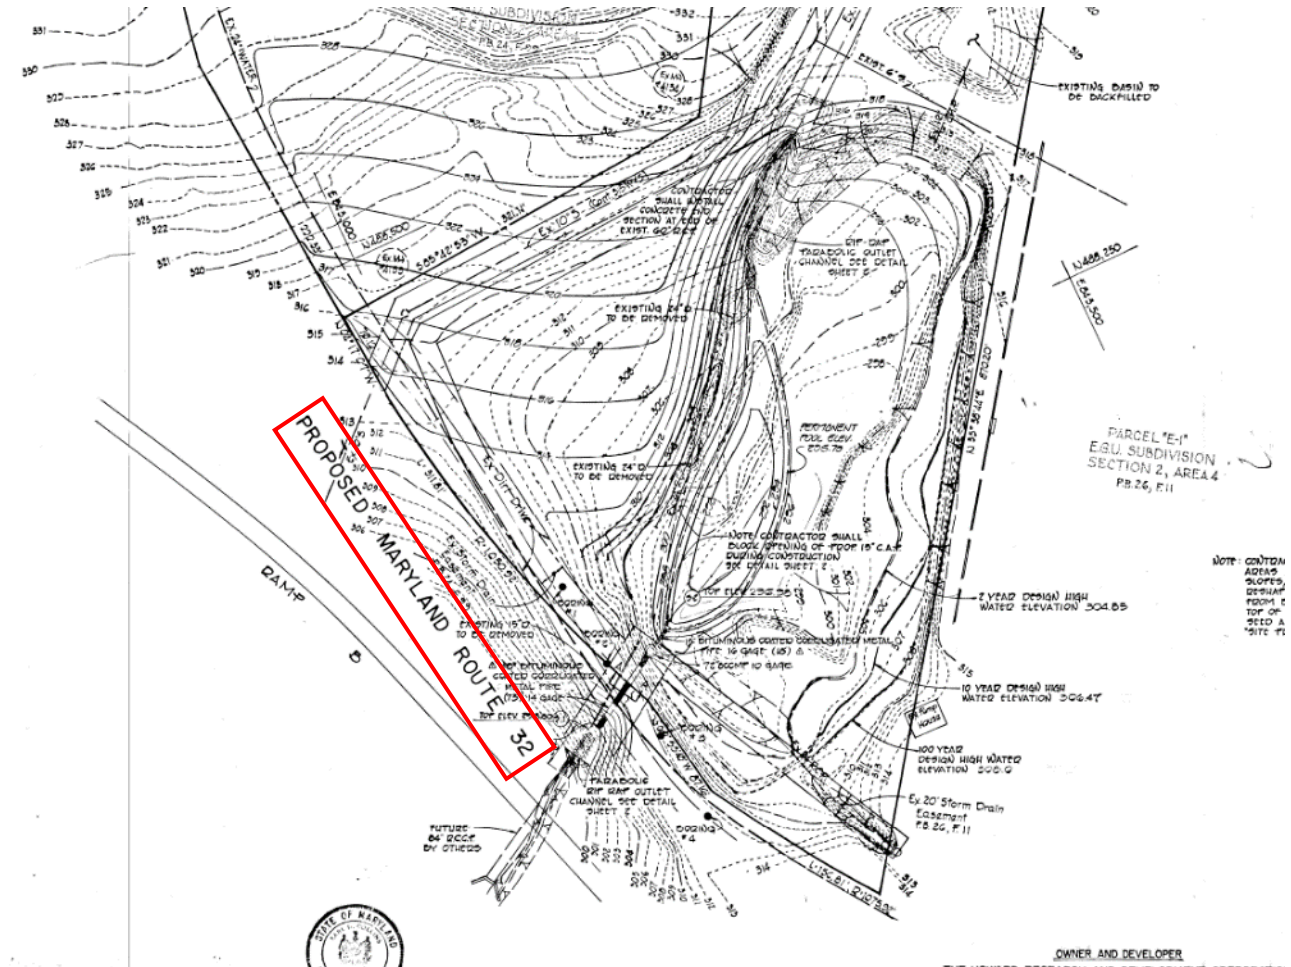
HAZARD CREEP

- MD 32 built below the dam after pond construction
- Original drawings reference “Proposed Maryland Route 32”
- No consideration in 1982 design for Probable Maximum Flood (PMF) event
- Highway beneath dam caused elevated hazard classification (HIGH)
